# Access Compliance Report

## Public Rights-of-Way

### (Curb Ramps)

Intersection ID: 7091	Main Street: BROOKSHIRE_BV	Cross Street: HOVIS_RD	Location:	E
ADA ID: 914C92E39BE4	Ramp Type: Perp	Initial Pass/Fail: Fail	Overall Compliance: No	Severity Score: 8.75
Codes/Mitigation Info/Possible Solution		Field Measurements/Component Compliance

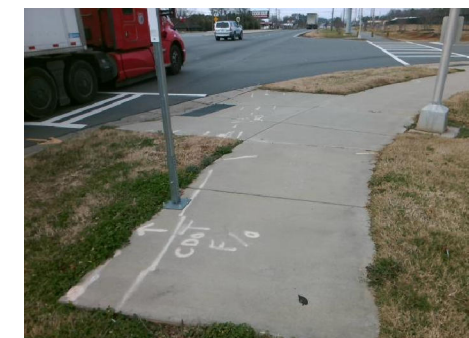
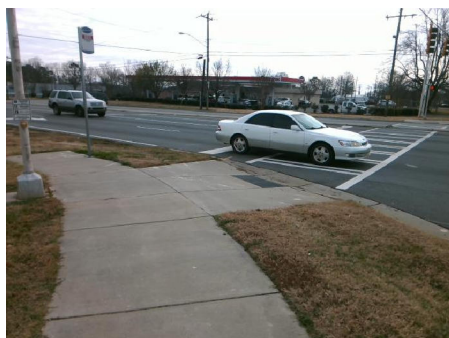
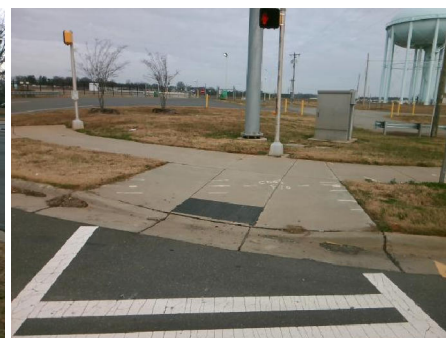
Compliance	Description	Data	Compliance	Description	Data
N/A	Ramp Length (in)	96.0	Yes	Ramp Slope (%)	8.1
No	Ramp Width (in)	47.0	Yes	Ramp XSlope (%)	0.2
N/A	Flare Type LT	N/A	N/A	Flare Type RT	N/A
N/A	Flare Slope LT (%)	N/A	N/A	Flare Slope RT (%)	N/A
N/A	Flare Traversable LT?	N/A	N/A	Flare Traversable RT?	N/A
N/A	Landing Length (in)	N/A	N/A	DWS Provided?	N/A
N/A	Landing Width (in)	N/A	N/A	DWS Contrast?	N/A
N/A	Landing Slope (%)	N/A	N/A	DWS Length (in)	N/A
N/A	Landing X Slope (%)	N/A	N/A	DWS Full Width?	N/A
N/A	Landing Curb? (Y/N)	N/A	N/A	DWS Offset (in)	N/A
N/A	Shared Landing?	N/A			
N/A	Gutter Ponding?	N/A	N/A	Gutter Slope (%)	N/A
N/A	Gutter Lip Ht (in)	N/A	N/A	Gutter X Slope (%)	N/A
N/A	Painted X Walk1?	Yes	N/A	Painted X Walk2?	N/A
	X Walk 1 Direction	To SW		X Walk 2 Direction	N/A
N/A	X Walk 1 Width (in)	112.0	N/A	X Walk 2 Width (in)	N/A
	X Walk 1 Slope (%)	0.1		X Walk 2 Slope (%)	N/A
	X Walk 1 X Slope (%)	2.3		X Walk 2 X Slope (%)	N/A

**Remove & Replace Entire Ramp.**

**R304.5.1**

**\$ 1850.00**
