Access Compliance Report

Public Rights-of-Way

(Curb Ramps)

Intersection ID: N/A	Main Street: ELEANOR_RIGBY_RD	Cross Street: MAGGIE_MAY_LN	Location: NW
ADA ID: 914CF5C66ADE	Ramp Type: Perp	Initial Pass/Fail: Fail	Overall Compliance: No
Severity Score: 8.75			
Codes/Mitigation Info/Possible Solution		Field Measurements/Component Compliance

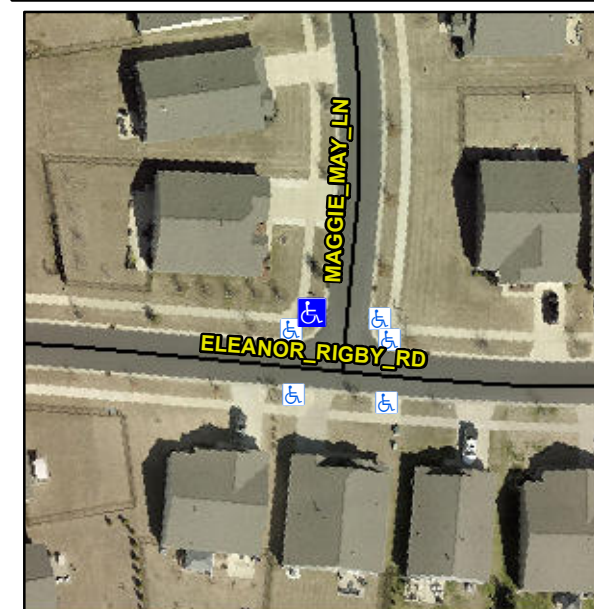
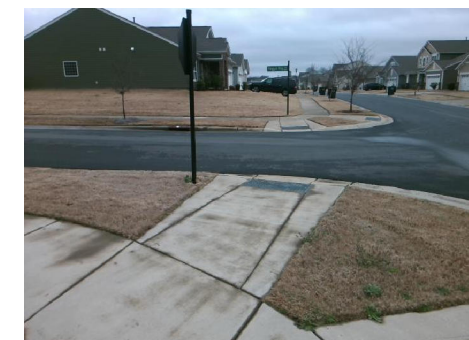
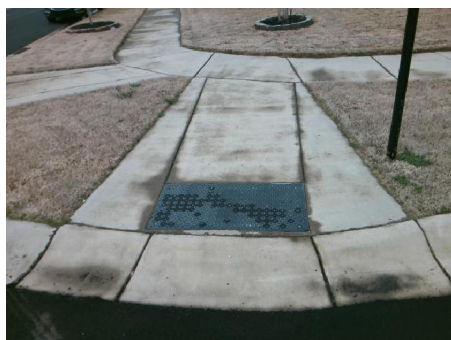
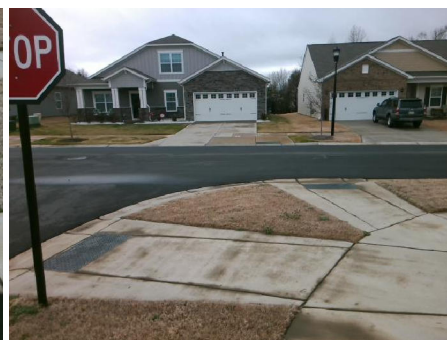
Not Found, R304.5.1

Compliance	Description	Data	Compliance	Description	Data
N/A	Ramp Length (in)	132.0	Yes	Ramp Slope (%)	6.0
No	Ramp Width (in)	45.0	Yes	Ramp XSlope (%)	0.4
N/A	Flare Type LT	N/A	N/A	Flare Type RT	N/A
N/A	Flare Slope LT (%)	N/A	N/A	Flare Slope RT (%)	N/A
N/A	Flare Traversable LT?	N/A	N/A	Flare Traversable RT?	N/A
N/A	Landing Length (in)	N/A	N/A	DWS Provided?	N/A
N/A	Landing Width (in)	N/A	N/A	DWS Contrast?	N/A
N/A	Landing Slope (%)	N/A	N/A	DWS Length (in)	N/A
N/A	Landing X Slope (%)	N/A	N/A	DWS Full Width?	N/A
N/A	Landing Curb? (Y/N)	N/A	N/A	DWS Offset (in)	N/A
N/A	Shared Landing?	N/A			
N/A	Gutter Ponding?	N/A	N/A	Gutter Slope (%)	N/A
N/A	Gutter Lip Ht (in)	N/A	N/A	Gutter X Slope (%)	N/A
N/A	Painted X Walk1?	No	N/A	Painted X Walk2?	N/A
	X Walk 1 Direction	To SE		X Walk 2 Direction	N/A
N/A	X Walk 1 Width (in)	N/A	N/A	X Walk 2 Width (in)	N/A
	X Walk 1 Slope (%)	2.5		X Walk 2 Slope (%)	N/A
	X Walk 1 X Slope (%)	0.1		X Walk 2 X Slope (%)	N/A

N/A	Ramp inside XWalk1?	N/A	N/A	Ramp inside XWalk2?	N/A
	Road Slope (%)	N/A	N/A	Clear Space?	N/A
	Road X Slope (%)	N/A	N/A	Clear Space to XWalk (in)	N/A
N/A	Any Obstructions?	N/A	N/A	Storm Grate/Utility Hazard?	N/A
	Obstruction Type			Storm Grate/Utility Type	
		N/A			N/A
			Yes	Surface Condition? (G/P)	Good

Possible Solutions:

Remove & Replace Entire Ramp.

Total Cost: \$ 1850.00
