# Access Compliance Report

## Public Rights-of-Way

### (Curb Ramps)

| Intersection ID: 15049 | Main Street: DILWORTH_RD_WEST | Cross Street: MAGNOLIA_AV | Location: NW |

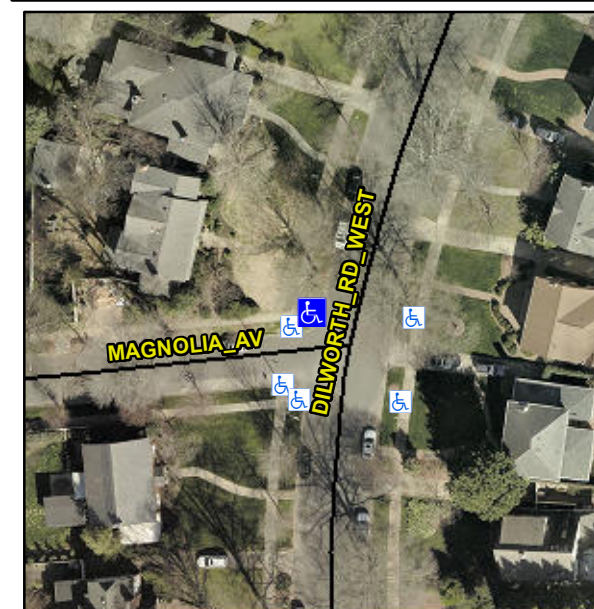
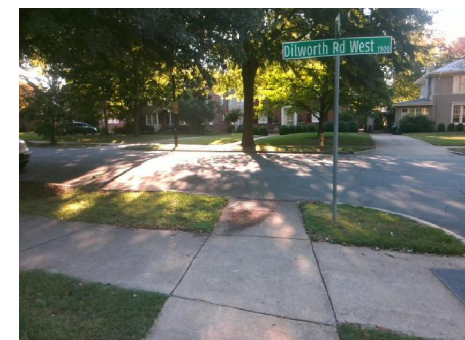
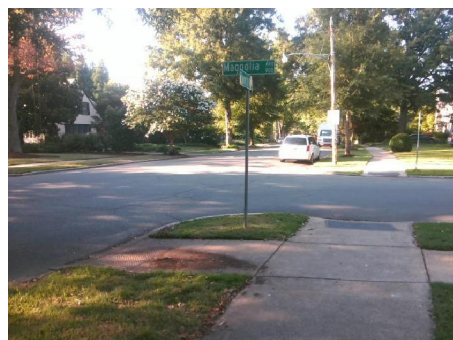
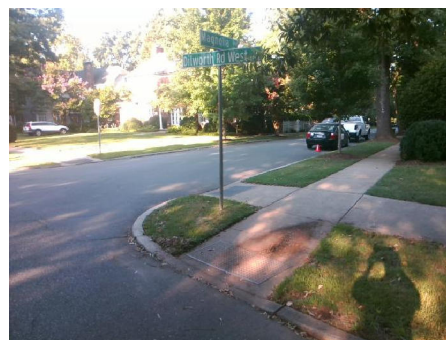
**R304.5.3, R305.1.4, R305.2, R302.7.2, R304.5.4**

| Compliance | Description | Data | Compliance | Description | Data |
|---|---|---|---|---|---|
| No | Landing X Slope (%) | 2.2 | No | DWS Full Width? | No |
| N/A | Landing Curb? (Y/N) | No | No | DWS Offset (in) | 7.0 |
| No | Gutter Lip Ht (in) | 1.0 | Yes | Gutter X Slope (%) | 1.3 |

**Remove & Replace Curb Ramp With Two New Directional Ramps or Equivalent. Remove & Replace Gutter.**
