ADA ID: 916145BB62AD

Access Compliance Report Public Rights-of-Way (Curb Ramps)

Intersection ID: 10039828 Main Street: TOMLIN GREEN LN Cross Street: N/A Location: S **Overall Compliance: No**

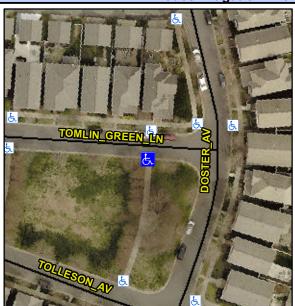
Initial Pass/Fail: Fail

Ramp Type: Perp

i cecibie celation						
	Possible Solutions:						
1	Remove & Replace Entire Ramp.						
200							
The same							
1							
	Surveyor Notes:						
	N/A						
	N/A						
2							
3							
A	PROW/ADA:						
	R304.2.2						
5							
á
