Access Compliance Report

Public Rights-of-Way

(Curb Ramps)

Intersection ID: 10308	Main Street: BRICE_ST	Cross Street: RUSH_AV	Location: SW
ADA ID: 9169FAB4C3CC	Ramp Type: PerpDiag	Initial Pass/Fail: Fail	Overall Compliance: No
		Severity Score: 15

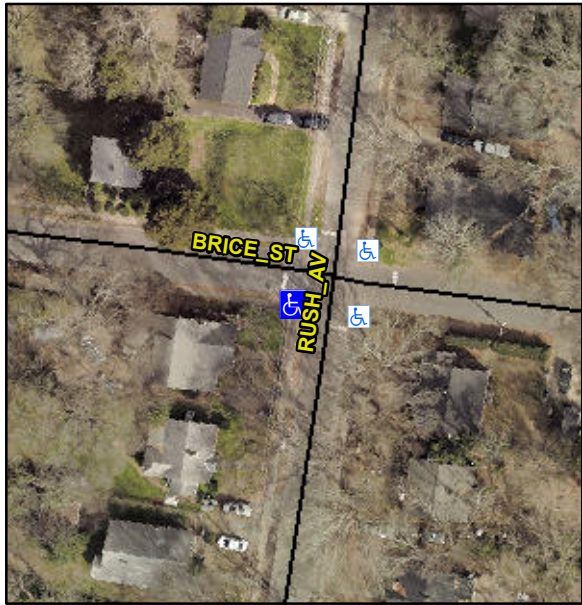
Possible Solutions:		Compliance	Description	Data	Compliance	Description	Data
	Remove & Replace Curb Ramp With Two New Directional Ramps or Equivalent.		N/A	Ramp Length (in)	48.0	No	Ramp Slope (%)	N/A
			Yes	Ramp Width (in)	48.0	No	Ramp XSlope (%)	N/A
			N/A	Flare Type LT	N/A	N/A	Flare Type RT	N/A
			N/A	Flare Slope LT (%)	N/A	N/A	Flare Slope RT (%)	N/A
			N/A	Flare Traversable LT?	N/A	N/A	Flare Traversable RT?	N/A
			N/A	Landing Length (in)	N/A	N/A	DWS Provided?	N/A
			N/A	Landing Width (in)	N/A	N/A	DWS Contrast?	N/A
			N/A	Landing Slope (%)	N/A	N/A	DWS Length (in)	N/A
			N/A	Landing X Slope (%)	N/A	N/A	DWS Full Width?	N/A
<p>Surveyor Notes:</p> <p>N/A</p> <p>PROW/ADA:</p> <p>R304.2.2, R304.5.3, R302.7</p>			N/A	Landing Curb? (Y/N)	N/A	N/A	DWS Offset (in)	N/A
			N/A	Shared Landing?	N/A			
			N/A	Gutter Ponding?	N/A	N/A	Gutter Slope (%)	N/A

N/A	Gutter Lip Ht (in)	N/A	N/A	Gutter X Slope (%)	N/A
			N/A	Painted X Walk1?	No	N/A	Painted X Walk2?	No
				X Walk 1 Direction	To E		X Walk 2 Direction	To N
			N/A	X Walk 1 Width (in)	N/A	N/A	X Walk 2 Width (in)	N/A
				X Walk 1 Slope (%)	N/A		X Walk 2 Slope (%)	N/A
				X Walk 1 X Slope (%)	N/A		X Walk 2 X Slope (%)	N/A
			N/A	Ramp inside XWalk1?	N/A	N/A	Ramp inside XWalk2?	N/A
<p>Street 1 Name</p> <p>Stop Condition-Street 2</p> <p>Street 2 Name</p> <p>Stop Condition-Street 1</p>			Road Slope (%)	N/A	N/A	Clear Space?	N/A	
			Road X Slope (%)	N/A	N/A	Clear Space to XWalk (in)	N/A	
		N/A	Any Obstructions?	N/A	N/A	Storm Grate/Utility Hazard?	Yes	
			Obstruction Type			Storm Grate/Utility Type		
				N/A		MH		
				No	Surface Condition? (G/P)	Poor		
Total Cost:		\$	3200.00
