# Access Compliance Report

## Public Rights-of-Way

### (Curb Ramps)

Intersection ID: 18436	Main Street: E_INDEPENDENCE_BV	Cross Street: SHARON_FOREST_DR	Location: NW
ADA ID: 9193D4B5D4CD	Ramp Type: PerpDiag	Initial Pass/Fail: Fail	Overall Compliance: No
Severity Score: 10			
Codes/Mitigation Info/Possible Solution		Field Measurements/Component Compliance

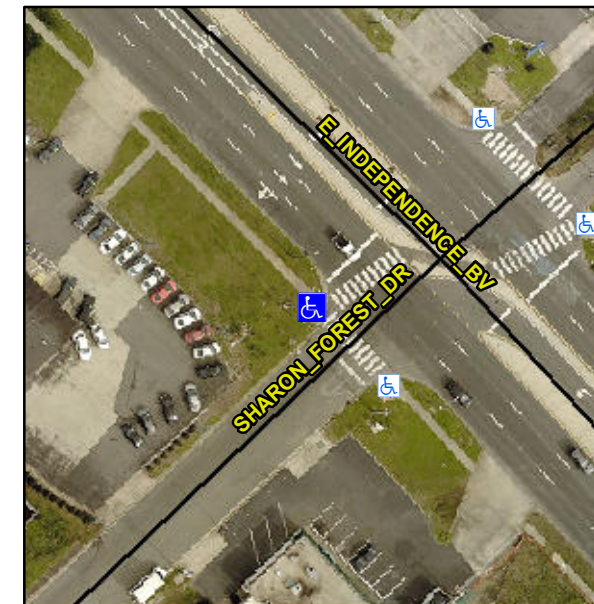
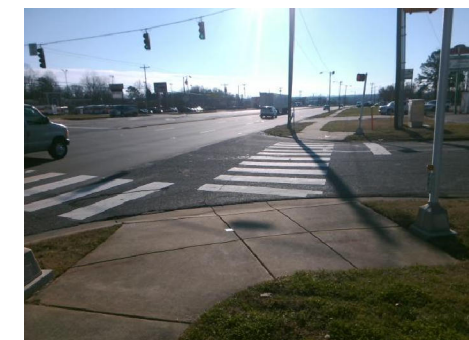
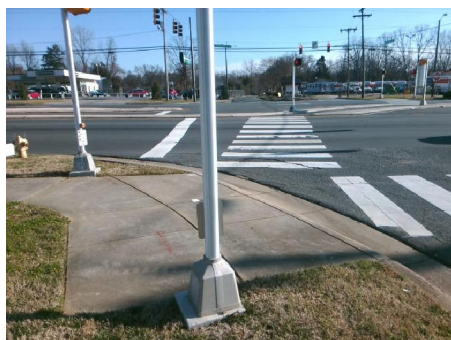
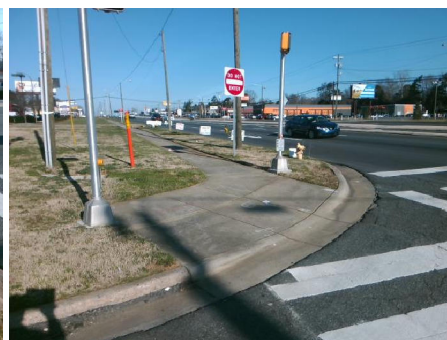
**Not Found, R304.5.1, R304.5.3**

Compliance	Description	Data	Compliance	Description	Data
N/A	Ramp Length (in)	115.5	Yes	Ramp Slope (%)	6.6
No	Ramp Width (in)	39.0	No	Ramp XSlope (%)	5.0
N/A	Flare Type LT	N/A	N/A	Flare Type RT	N/A
N/A	Flare Slope LT (%)	N/A	N/A	Flare Slope RT (%)	N/A
N/A	Flare Traversable LT?	N/A	N/A	Flare Traversable RT?	N/A
N/A	Landing Length (in)	N/A	N/A	DWS Provided?	N/A
N/A	Landing Width (in)	N/A	N/A	DWS Contrast?	N/A
N/A	Landing Slope (%)	N/A	N/A	DWS Length (in)	N/A
N/A	Landing X Slope (%)	N/A	N/A	DWS Full Width?	N/A
N/A	Landing Curb? (Y/N)	N/A	N/A	DWS Offset (in)	N/A
N/A	Shared Landing?	N/A			
N/A	Gutter Ponding?	N/A	N/A	Gutter Slope (%)	N/A
N/A	Gutter Lip Ht (in)	N/A	N/A	Gutter X Slope (%)	N/A
N/A	Painted X Walk1?	Yes	N/A	Painted X Walk2?	Yes
	X Walk 1 Direction	To SE		X Walk 2 Direction	To NE
N/A	X Walk 1 Width (in)	117.0	N/A	X Walk 2 Width (in)	118.0
	X Walk 1 Slope (%)	0.8		X Walk 2 Slope (%)	1.9
	X Walk 1 X Slope (%)	5.3		X Walk 2 X Slope (%)	1.8

N/A	Ramp inside XWalk1?	Yes	N/A	Ramp inside XWalk2?	Yes
	Road Slope (%)	4.0	N/A	Clear Space?	N/A
	Road X Slope (%)	0.4	N/A	Clear Space to XWalk (in)	N/A
N/A	Any Obstructions?	N/A	N/A	Storm Grate/Utility Hazard?	N/A
	Obstruction Type			Storm Grate/Utility Type	
		N/A			N/A
		Yes		Surface Condition? (G/P)	Good

**Remove & Replace Curb Ramp With Two New Directional Ramps or Equivalent.**
