# Access Compliance Report

## Public Rights-of-Way

### (Curb Ramps)

| Intersection ID: 2877 | Main Street: GOLDENFIELD_DR | Cross Street: FOGGY_MEADOW_RD | Location: | N |

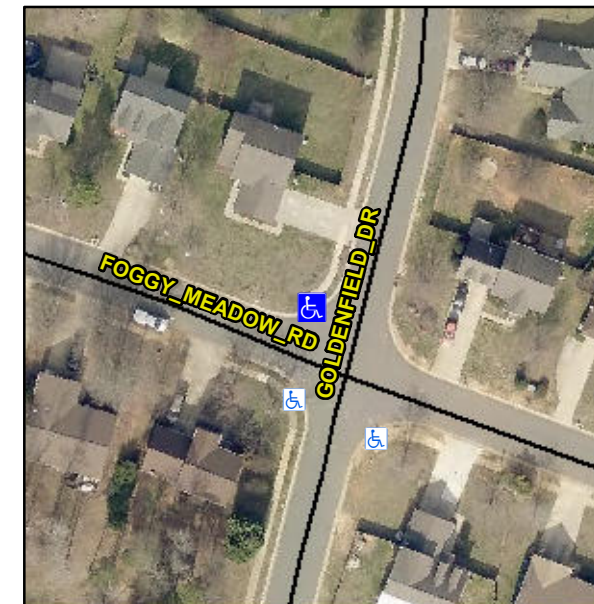
**Not Found, R304.2.1, R304.2.2-Perp,  
R304.3.2-Para, R304.5.3, R305.2**

| Compliance | Description | Data | Compliance | Description | Data |
|---|---|---|---|---|---|
| No | Landing Length (in) | 46.5 | Yes | DWS Provided? | Yes |
| No | Landing Slope (%) | 3.0 | Yes | DWS Length (in) | 25.5 |
| No | Landing X Slope (%) | 2.8 | Yes | DWS Full Width? | Yes |
| N/A | Landing Curb? (Y/N) | No | No | DWS Offset (in) | 3.0 |
| Yes | Gutter Lip Ht (in) | 0.0 | No | Gutter X Slope (%) | 3.8 |

**Remove & Replace Entire Ramp.  
Remove & Replace Gutter.**

Total Cost: \$ 2600.00
