# Access Compliance Report

## Public Rights-of-Way

### (Curb Ramps)

Intersection ID: 30070	Main Street: SOUTHWIND_DR	Cross Street: WATERS_TRAIL_DR	Location: NW
ADA ID: 91A0A5F5B574	Ramp Type: PerpDiag	Initial Pass/Fail: Pass	Overall Compliance: No
		Severity Score: 0

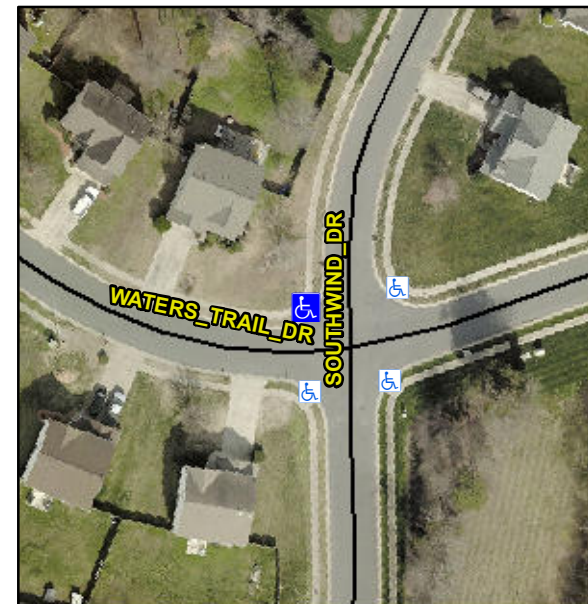
Codes/Mitigation Info/Possible Solution	Field Measurements/Component Compliance
---	---

**Not Found, R304.2.1, R304.2.2-Perp, R304.3.2-Para, R304.5.3, R305.2**

Compliance	Description	Data	Compliance	Description	Data
N/A	Ramp Length (in)	48.0	Yes	Ramp Slope (%)	7.5
Yes	Ramp Width (in)	48.0	Yes	Ramp XSlope (%)	2.0
N/A	Flare Type LT	Sloped	N/A	Flare Type RT	N/A
N/A	Flare Slope LT (%)	1.2	N/A	Flare Slope RT (%)	1.5
N/A	Flare Traversable LT?	No	N/A	Flare Traversable RT?	No
No	Landing Length (in)	44.0	Yes	DWS Provided?	Yes
Yes	Landing Width (in)	48.0	Yes	DWS Contrast?	Yes
No	Landing Slope (%)	4.2	Yes	DWS Length (in)	24.0
No	Landing X Slope (%)	2.7	Yes	DWS Full Width?	Yes
N/A	Landing Curb? (Y/N)	No	No	DWS Offset (in)	4.0
N/A	Shared Landing?	No			
Yes	Gutter Ponding?	No	Yes	Gutter Slope (%)	4.6
Yes	Gutter Lip Ht (in)	0.0	Yes	Gutter X Slope (%)	1.7
N/A	Painted X Walk1?	No	N/A	Painted X Walk2?	No
	X Walk 1 Direction	To S		X Walk 2 Direction	To E
N/A	X Walk 1 Width (in)	N/A	N/A	X Walk 2 Width (in)	N/A
	X Walk 1 Slope (%)	1.9		X Walk 2 Slope (%)	5.2
	X Walk 1 X Slope (%)	2.4		X Walk 2 X Slope (%)	0.8

N/A	Ramp inside XWalk1?	N/A	N/A	Ramp inside XWalk2?	N/A
	Road Slope (%)	0.8	N/A	Clear Space?	Yes
	Road X Slope (%)	3.0	N/A	Clear Space to XWalk (in)	N/A
Yes	Any Obstructions?	No	Yes	Storm Grate/Utility Hazard?	No
	Obstruction Type			Storm Grate/Utility Type	
		N/A			N/A
			Yes	Surface Condition? (G/P)	Good

**Remove & Replace Curb Ramp With Two New Directional Ramps or Equivalent.**
