Access Compliance Report

Public Rights-of-Way

(Curb Ramps)

Intersection ID: 31894	Main Street: GREEN_MOUNTAIN_RD	Cross Street: MOUNTAIN_SPRINGS_DR	Location: E
ADA ID: 91A0C7D56B50	Ramp Type: PerpDiag	Initial Pass/Fail: Fail	Overall Compliance: No
Severity Score: 10			
Codes/Mitigation Info/Possible Solution		Field Measurements/Component Compliance

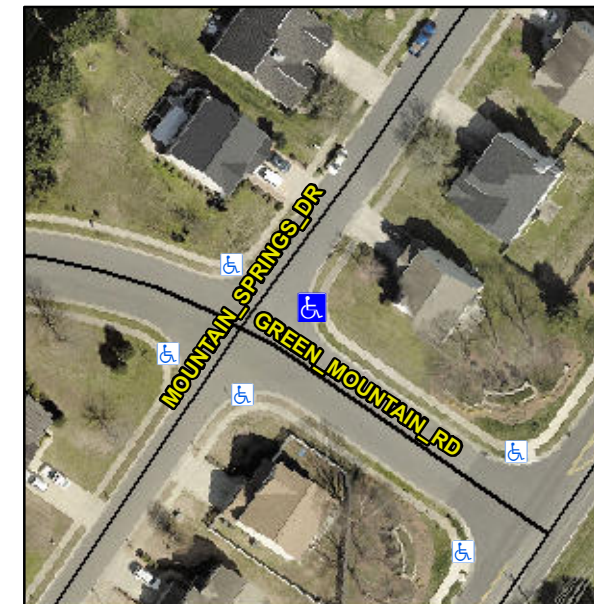
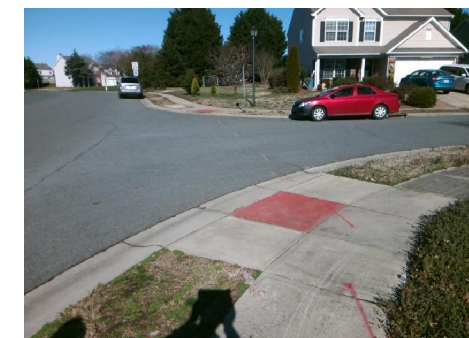
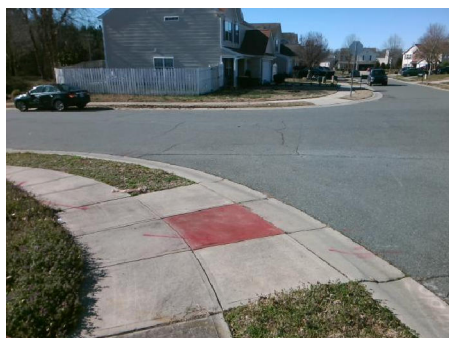
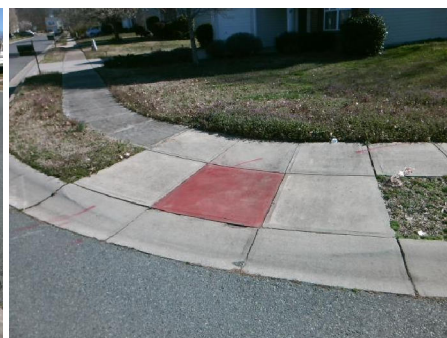
R304.5.1, R304.5.3

Compliance	Description	Data	Compliance	Description	Data
N/A	Ramp Length (in)	48.0	Yes	Ramp Slope (%)	5.3
No	Ramp Width (in)	42.0	No	Ramp XSlope (%)	4.5
N/A	Flare Type LT	N/A	N/A	Flare Type RT	N/A
N/A	Flare Slope LT (%)	N/A	N/A	Flare Slope RT (%)	N/A
N/A	Flare Traversable LT?	N/A	N/A	Flare Traversable RT?	N/A
N/A	Landing Length (in)	N/A	N/A	DWS Provided?	N/A
N/A	Landing Width (in)	N/A	N/A	DWS Contrast?	N/A
N/A	Landing Slope (%)	N/A	N/A	DWS Length (in)	N/A
N/A	Landing X Slope (%)	N/A	N/A	DWS Full Width?	N/A
N/A	Landing Curb? (Y/N)	N/A	N/A	DWS Offset (in)	N/A
N/A	Shared Landing?	N/A			
N/A	Gutter Ponding?	N/A	N/A	Gutter Slope (%)	N/A
N/A	Gutter Lip Ht (in)	N/A	N/A	Gutter X Slope (%)	N/A
N/A	Painted X Walk1?	No	N/A	Painted X Walk2?	No
	X Walk 1 Direction	To NW		X Walk 2 Direction	To SW
N/A	X Walk 1 Width (in)	N/A	N/A	X Walk 2 Width (in)	N/A
	X Walk 1 Slope (%)	4.4		X Walk 2 Slope (%)	1.3
	X Walk 1 X Slope (%)	0.3		X Walk 2 X Slope (%)	4.4

N/A	Ramp inside XWalk1?	N/A	N/A	Ramp inside XWalk2?	N/A
	Road Slope (%)	1.0	N/A	Clear Space?	N/A
	Road X Slope (%)	2.8	N/A	Clear Space to XWalk (in)	N/A
N/A	Any Obstructions?	N/A	N/A	Storm Grate/Utility Hazard?	N/A
	Obstruction Type			Storm Grate/Utility Type	
		N/A			N/A
			Yes	Surface Condition? (G/P)	Good

Remove & Replace Curb Ramp With Two New Directional Ramps or Equivalent.

Total Cost: \$ 3200.00
