Access Compliance Report

Public Rights-of-Way

(Curb Ramps)

Intersection ID: 27388	Main Street: CONLAN_CR	Cross Street: BRIXHAM_HILL_AV	Location: SE
ADA ID: 91A3AE9F6DB7	Ramp Type: Perp	Initial Pass/Fail: Fail	Overall Compliance: No
Severity Score: 8.75			
Codes/Mitigation Info/Possible Solution		Field Measurements/Component Compliance

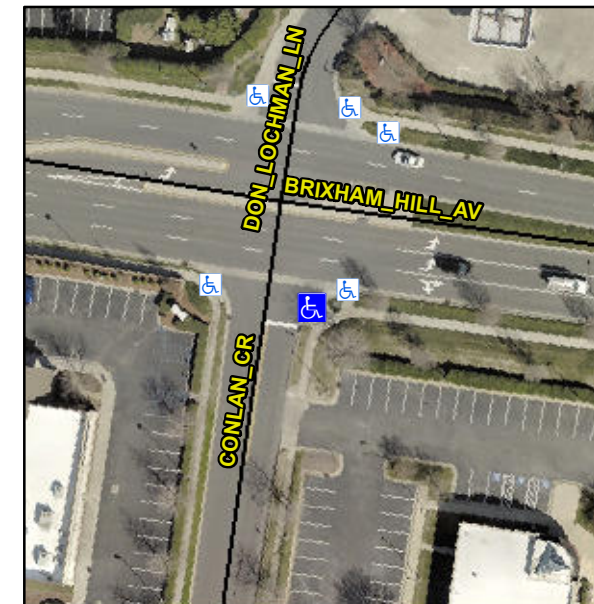
Compliance	Description	Data	Compliance	Description	Data
N/A	Ramp Length (in)	68.0	Yes	Ramp Slope (%)	7.5
No	Ramp Width (in)	47.0	Yes	Ramp XSlope (%)	1.6
N/A	Flare Type LT	N/A	N/A	Flare Type RT	N/A
N/A	Flare Slope LT (%)	N/A	N/A	Flare Slope RT (%)	N/A
N/A	Flare Traversable LT?	N/A	N/A	Flare Traversable RT?	N/A
N/A	Landing Length (in)	N/A	N/A	DWS Provided?	N/A
N/A	Landing Width (in)	N/A	N/A	DWS Contrast?	N/A
N/A	Landing Slope (%)	N/A	N/A	DWS Length (in)	N/A
N/A	Landing X Slope (%)	N/A	N/A	DWS Full Width?	N/A
N/A	Landing Curb? (Y/N)	N/A	N/A	DWS Offset (in)	N/A
N/A	Shared Landing?	N/A			
N/A	Gutter Ponding?	N/A	N/A	Gutter Slope (%)	N/A
N/A	Gutter Lip Ht (in)	N/A	N/A	Gutter X Slope (%)	N/A
N/A	Painted X Walk1?	No	N/A	Painted X Walk2?	N/A
	X Walk 1 Direction	To W		X Walk 2 Direction	N/A
N/A	X Walk 1 Width (in)	N/A	N/A	X Walk 2 Width (in)	N/A
	X Walk 1 Slope (%)	3.7		X Walk 2 Slope (%)	N/A
	X Walk 1 X Slope (%)	2.1		X Walk 2 X Slope (%)	N/A

N/A	Ramp inside XWalk1?	N/A	N/A	Ramp inside XWalk2?	N/A
	Road Slope (%)	N/A	N/A	Clear Space?	N/A
	Road X Slope (%)	N/A	N/A	Clear Space to XWalk (in)	N/A
N/A	Any Obstructions?	N/A	N/A	Storm Grate/Utility Hazard?	N/A
	Obstruction Type			Storm Grate/Utility Type	
		N/A			N/A
		Yes		Surface Condition? (G/P)	Good

Possible Solutions:

Remove & Replace Entire Ramp.
