Access Compliance Report

Public Rights-of-Way

(Curb Ramps)

Intersection ID: 10034609	Main Street: PLANTATION_CENTER_DR	Cross Street: N/A	Location: NW
ADA ID: 91AA87B9BD04	Ramp Type: Para	Initial Pass/Fail: Fail	Overall Compliance: No
Severity Score: 13.75			
Codes/Mitigation Info/Possible Solution		Field Measurements/Component Compliance

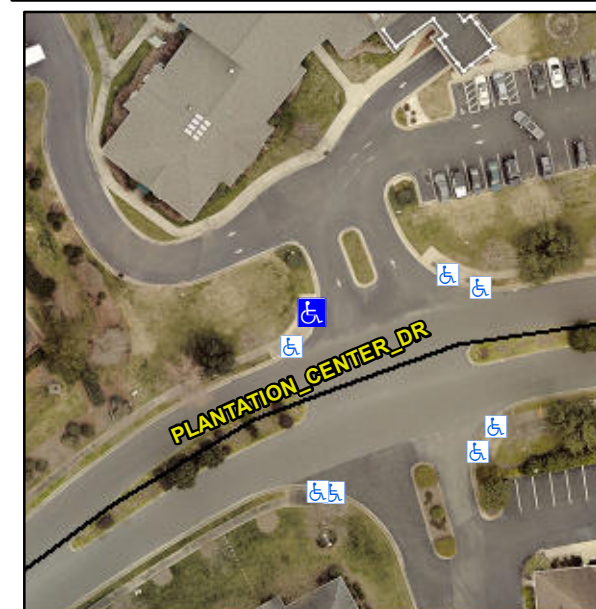
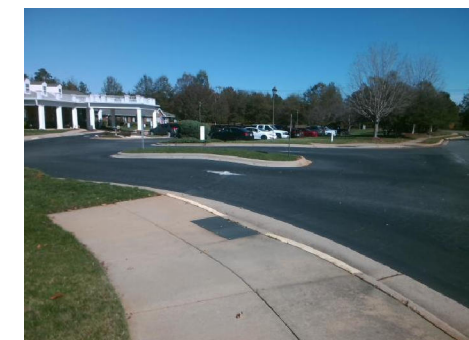
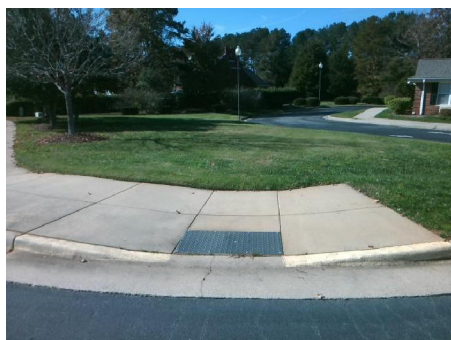
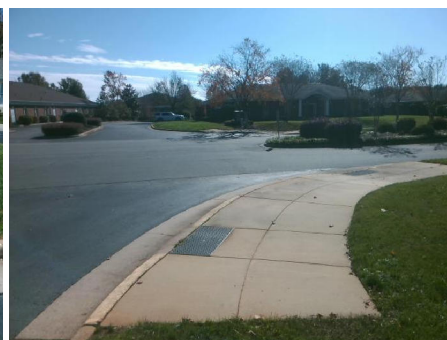
R304.5.3, R304.3.2

Compliance	Description	Data	Compliance	Description	Data
N/A	Ramp Length LT (in)	59.0	N/A	Ramp Length RT (in)	53.0
Yes	Ramp Width LT (in)	96.0	Yes	Ramp Width RT (in)	96.0
Yes	Ramp Slope LT (%)	4.8	No	Ramp Slope RT (%)	10.1
No	Ramp XSlope LT (%)	2.4	No	Ramp XSlope RT (%)	2.4
N/A	Landing Length (in)	N/A	N/A	DWS Provided?	N/A
N/A	Landing Width (in)	N/A	N/A	DWS Contrast?	N/A
N/A	Landing Slope (%)	N/A	N/A	DWS Length (in)	N/A
N/A	Landing X Slope (%)	N/A	N/A	DWS Full Width?	N/A
N/A	Landing Curb? (Y/N)	N/A	N/A	DWS Offset (in)	N/A
N/A	Shared Landing?	N/A			
N/A	Gutter Ponding?	N/A	N/A	Gutter Slope (%)	N/A
N/A	Gutter Lip Ht (in)	N/A	N/A	Gutter X Slope (%)	N/A
N/A	Painted X Walk1?	No	N/A	Painted X Walk2?	N/A
	X Walk 1 Direction	To NE		X Walk 2 Direction	N/A
N/A	X Walk 1 Width (in)	N/A	N/A	X Walk 2 Width (in)	N/A
	X Walk 1 Slope (%)	1.1		X Walk 2 Slope (%)	N/A
	X Walk 1 X Slope (%)	3.1		X Walk 2 X Slope (%)	N/A
N/A	Ramp inside XWalk1?	N/A	N/A	Ramp inside XWalk2?	N/A

Road Slope (%)	N/A	N/A	Clear Space?	N/A
	Road X Slope (%)	N/A	N/A	Clear Space to XWalk (in)	N/A
N/A	Any Obstructions?	N/A	N/A	Storm Grate/Utility Hazard?	N/A
	Obstruction Type			Storm Grate/Utility Type	
		N/A			N/A
			Yes	Surface Condition? (G/P)	Good
			N/A	Curb Slope (%)	9.5

Remove & Replace Entire Ramp.
