Access Compliance Report

Public Rights-of-Way

(Curb Ramps)

Intersection ID: 14078	Main Street: EAST_BV	Cross Street: SOUTH_BV	Location: E
ADA ID: 91AA893BFE8F	Ramp Type: BlendTrans2	Initial Pass/Fail: Fail	Overall Compliance: No
Severity Score: 8.75			
Codes/Mitigation Info/Possible Solution		Field Measurements/Component Compliance

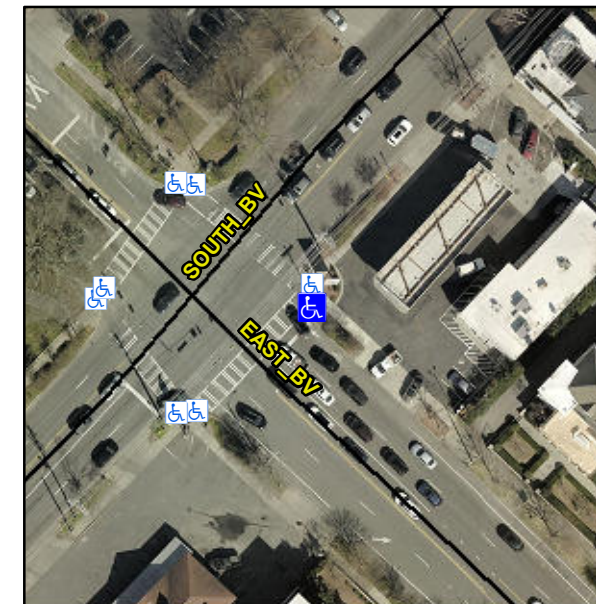
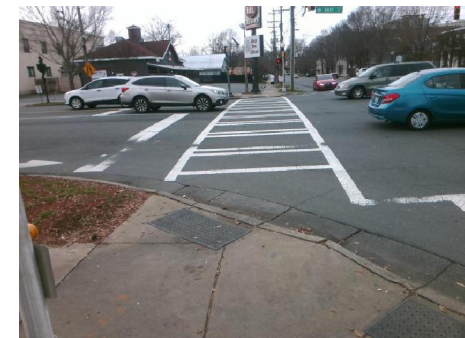
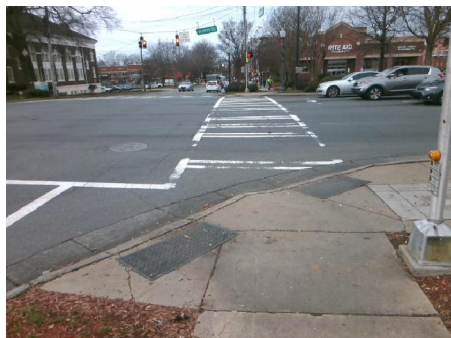
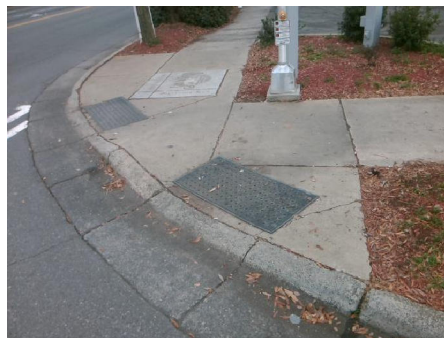
Not Found, R304.5.1

Compliance	Description	Data	Compliance	Description	Data
N/A	Ramp Length (in)	51.0	Yes	BlendTrans Slope (%)	0.1
No	Ramp Width (in)	45.0	Yes	BlendTrans XSlope (%)	0.6
N/A	Flare Type LT	N/A	N/A	Flare Type RT	N/A
N/A	Flare Slope LT (%)	N/A	N/A	Flare Slope RT (%)	N/A
N/A	Flare Traversable LT?	N/A	N/A	Flare Traversable RT?	N/A
N/A	Landing Length (in)	N/A	N/A	DWS Provided?	N/A
N/A	Landing Width (in)	N/A	N/A	DWS Contrast?	N/A
N/A	Landing Slope (%)	N/A	N/A	DWS Length (in)	N/A
N/A	Landing X Slope (%)	N/A	N/A	DWS Full Width?	N/A
N/A	Landing Curb? (Y/N)	N/A	N/A	DWS Offset (in)	N/A
N/A	Shared Landing?	N/A			
N/A	Gutter Ponding?	N/A	N/A	Gutter Slope (%)	N/A
N/A	Gutter Lip Ht (in)	N/A	N/A	Gutter X Slope (%)	N/A
N/A	Painted X Walk1?	Yes	N/A	Painted X Walk2?	N/A
	X Walk 1 Direction	To SW		X Walk 2 Direction	N/A
	X Walk 1 Width (in)	111.0		X Walk 2 Width (in)	N/A
	X Walk 1 Slope (%)	4.0		X Walk 2 Slope (%)	N/A
	X Walk 1 X Slope (%)	0.4		X Walk 2 X Slope (%)	N/A

N/A	Ramp inside XWalk1?	Yes	N/A	Ramp inside XWalk2?	N/A
	Road Slope (%)	0.4		Clear Space?	N/A
	Road X Slope (%)	4.0	N/A	Clear Space to XWalk (in)	N/A
N/A	Any Obstructions?	N/A	N/A	Storm Grate/Utility Hazard?	N/A
	Obstruction Type			Storm Grate/Utility Type	
		N/A			N/A
			Yes	Surface Condition? (G/P)	Good
			No	Curb Slope (%)	6.5

Remove & Replace Curb Ramp With Two New Directional Ramps or Equivalent.
