Access Compliance Report

Public Rights-of-Way

(Curb Ramps)

Intersection ID: 52246	Main Street: CENTERLINE_DR	Cross Street: KNOX_FARM_RD	Location: SW
ADA ID: 91B3274B5DA3	Ramp Type: Perp	Initial Pass/Fail: Fail	Overall Compliance: No
			Severity Score: 21.25

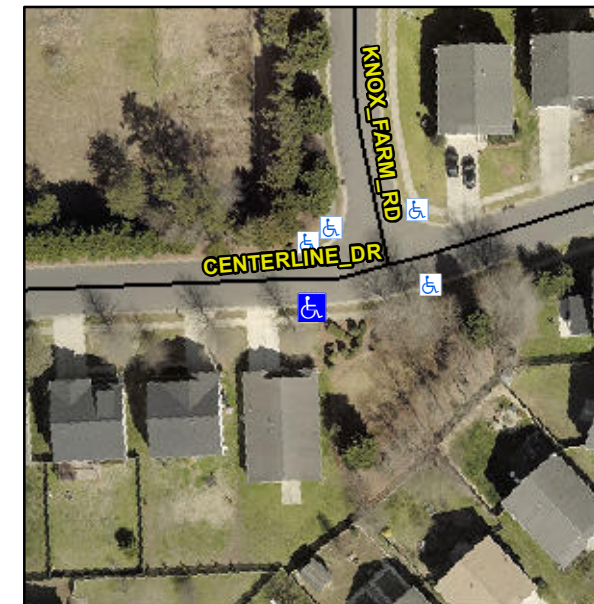
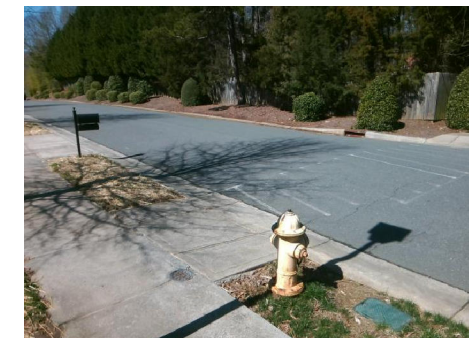
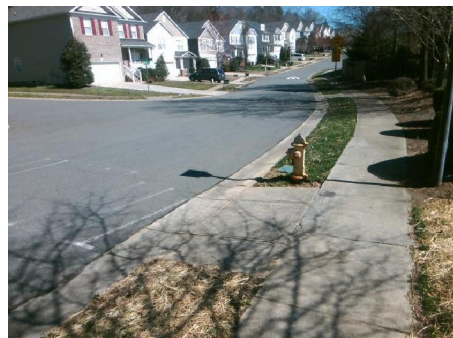
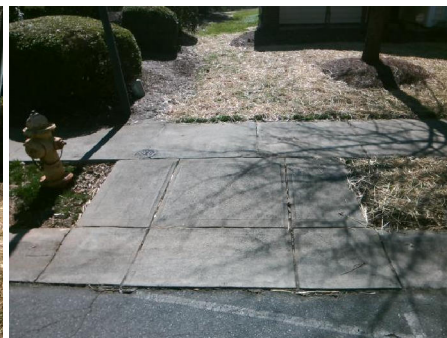
Not Found, R304.5.1, R304.2.2

Compliance	Description	Data	Compliance	Description	Data
N/A	Ramp Length (in)	47.5	No	Ramp Slope (%)	8.6
No	Ramp Width (in)	46.5	Yes	Ramp XSlope (%)	1.9
N/A	Flare Type LT	N/A	N/A	Flare Type RT	N/A
N/A	Flare Slope LT (%)	N/A	N/A	Flare Slope RT (%)	N/A
N/A	Flare Traversable LT?	N/A	N/A	Flare Traversable RT?	N/A
N/A	Landing Length (in)	N/A	N/A	DWS Provided?	N/A
N/A	Landing Width (in)	N/A	N/A	DWS Contrast?	N/A
N/A	Landing Slope (%)	N/A	N/A	DWS Length (in)	N/A
N/A	Landing X Slope (%)	N/A	N/A	DWS Full Width?	N/A
N/A	Landing Curb? (Y/N)	N/A	N/A	DWS Offset (in)	N/A
N/A	Shared Landing?	N/A			
N/A	Gutter Ponding?	N/A	N/A	Gutter Slope (%)	N/A
N/A	Gutter Lip Ht (in)	N/A	N/A	Gutter X Slope (%)	N/A
N/A	Painted X Walk1?	Yes	N/A	Painted X Walk2?	N/A
	X Walk 1 Direction	To N		X Walk 2 Direction	N/A
N/A	X Walk 1 Width (in)	103.0	N/A	X Walk 2 Width (in)	N/A
	X Walk 1 Slope (%)	6.7		X Walk 2 Slope (%)	N/A
	X Walk 1 X Slope (%)	2.4		X Walk 2 X Slope (%)	N/A

N/A	Ramp inside XWalk1?	Yes	N/A	Ramp inside XWalk2?	N/A
	Road Slope (%)	N/A	N/A	Clear Space?	N/A
	Road X Slope (%)	N/A	N/A	Clear Space to XWalk (in)	N/A
N/A	Any Obstructions?	N/A	N/A	Storm Grate/Utility Hazard?	N/A
	Obstruction Type			Storm Grate/Utility Type	
		N/A			N/A
			Yes	Surface Condition? (G/P)	Good

Remove & Replace Entire Ramp.

Total Cost: \$ 1850.00
