Good

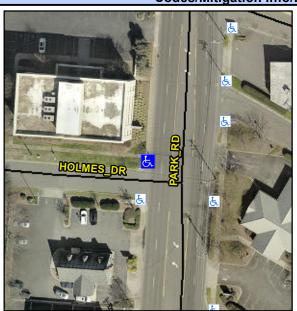
Total Cost: 3200.00

Field Measurements/Component Compliance						
Compli	ance Description	Data	Compl	iance	Description	Data
N/A	Ramp Length (in)	99.0	Yes	Blend	Trans Slope (%)	2.3
Yes	Ramp Width (in)	60.0	No	Blend	Trans XSlope (%)	3.8
N/A	Flare Type LT	N/A	N/A	Flare	Type RT	N/A
N/A	Flare Slope LT (%)	N/A	N/A	Flare	Slope RT (%)	N/A
N/A	Flare Traversable LT?	N/A	N/A	Flare	Traversable RT?	N/A
N/A	Landing Length (in)	N/A	N/A	DWS	Provided?	N/A
N/A	Landing Width (in)	N/A	N/A	DWS	Contrast?	N/A
N/A	Landing Slope (%)	N/A	N/A	DWS	Length (in)	N/A
N/A	Landing X Slope (%)	N/A	N/A	DWS	Full Width?	N/A
N/A	Landing Curb? (Y/N)	N/A	N/A	DWS	Offset (in)	N/A
N/A	Shared Landing?	N/A				
N/A	Gutter Ponding?	N/A	N/A	Gutte	r Slope (%)	N/A
N/A	Gutter Lip Ht (in)	N/A	N/A	Gutte	r X Slope (%)	N/A
N/A	Painted X Walk1?	No	N/A	Paint	ed X Walk2?	N/A
	X Walk 1 Direction	To S		X Wa	lk 2 Direction	N/A
	X Walk 1 Width (in)	N/A		X Wa	lk 2 Width (in)	N/A
	X Walk 1 Slope (%)	3.3		X Wa	lk 2 Slope (%)	N/A
