Access Compliance Report

Public Rights-of-Way

(Curb Ramps)

Intersection ID: N/A	Main Street: PAUL_BUCK_BV	Cross Street: N/A	Location: E
ADA ID: 91BC3A1506FB	Ramp Type: PerpDiag	Initial Pass/Fail: Fail	Overall Compliance: No
			Severity Score: 13.75

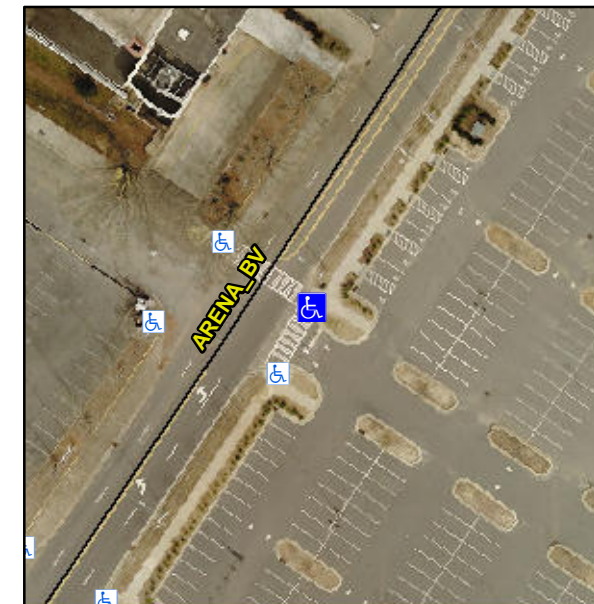
Not Found, R304.2.2, R304.5.3

Compliance	Description	Data	Compliance	Description	Data
N/A	Ramp Length (in)	95.0	No	Ramp Slope (%)	9.0
Yes	Ramp Width (in)	60.0	No	Ramp XSlope (%)	4.5
N/A	Flare Type LT	N/A	N/A	Flare Type RT	N/A
N/A	Flare Slope LT (%)	N/A	N/A	Flare Slope RT (%)	N/A
N/A	Flare Traversable LT?	N/A	N/A	Flare Traversable RT?	N/A
N/A	Landing Length (in)	N/A	N/A	DWS Provided?	N/A
N/A	Landing Width (in)	N/A	N/A	DWS Contrast?	N/A
N/A	Landing Slope (%)	N/A	N/A	DWS Length (in)	N/A
N/A	Landing X Slope (%)	N/A	N/A	DWS Full Width?	N/A
N/A	Landing Curb? (Y/N)	N/A	N/A	DWS Offset (in)	N/A
N/A	Shared Landing?	N/A			
N/A	Gutter Ponding?	N/A	N/A	Gutter Slope (%)	N/A
N/A	Gutter Lip Ht (in)	N/A	N/A	Gutter X Slope (%)	N/A
N/A	Painted X Walk1?	Yes	N/A	Painted X Walk2?	Yes
	X Walk 1 Direction	To NW		X Walk 2 Direction	To SW
N/A	X Walk 1 Width (in)	112.0	N/A	X Walk 2 Width (in)	111.0
	X Walk 1 Slope (%)	1.6		X Walk 2 Slope (%)	4.5
	X Walk 1 X Slope (%)	3.2		X Walk 2 X Slope (%)	1.1

N/A	Ramp inside XWalk1?	Yes	N/A	Ramp inside XWalk2?	Yes
	Road Slope (%)	3.7	N/A	Clear Space?	N/A
	Road X Slope (%)	1.2	N/A	Clear Space to XWalk (in)	N/A
N/A	Any Obstructions?	N/A	N/A	Storm Grate/Utility Hazard?	N/A
	Obstruction Type			Storm Grate/Utility Type	
		N/A			N/A
			Yes	Surface Condition? (G/P)	Good

Possible Solutions:

Remove & Replace Curb Ramp With Two New Directional Ramps or Equivalent.
