Access Compliance Report

Public Rights-of-Way

(Curb Ramps)

Intersection ID: 3194	Main Street: HIGHCROFT_LN	Cross Street: OLD_BRIDGE_LN	Location: SE
ADA ID: 91C3C132102A	Ramp Type: Perp	Initial Pass/Fail: Fail	Overall Compliance: No
Severity Score: 12.5			
Codes/Mitigation Info/Possible Solution		Field Measurements/Component Compliance

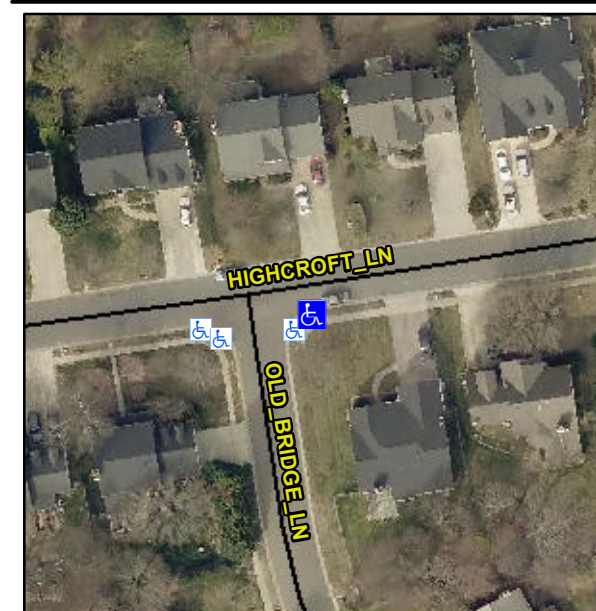
Not Found, R304.2.2

Compliance	Description	Data	Compliance	Description	Data
N/A	Ramp Length (in)	49.0	No	Ramp Slope (%)	8.6
Yes	Ramp Width (in)	49.0	Yes	Ramp XSlope (%)	0.3
N/A	Flare Type LT	N/A	N/A	Flare Type RT	N/A
N/A	Flare Slope LT (%)	N/A	N/A	Flare Slope RT (%)	N/A
N/A	Flare Traversable LT?	N/A	N/A	Flare Traversable RT?	N/A
N/A	Landing Length (in)	N/A	N/A	DWS Provided?	N/A
N/A	Landing Width (in)	N/A	N/A	DWS Contrast?	N/A
N/A	Landing Slope (%)	N/A	N/A	DWS Length (in)	N/A
N/A	Landing X Slope (%)	N/A	N/A	DWS Full Width?	N/A
N/A	Landing Curb? (Y/N)	N/A	N/A	DWS Offset (in)	N/A
N/A	Shared Landing?	N/A			
N/A	Gutter Ponding?	N/A	N/A	Gutter Slope (%)	N/A
N/A	Gutter Lip Ht (in)	N/A	N/A	Gutter X Slope (%)	N/A
N/A	Painted X Walk1?	No	N/A	Painted X Walk2?	N/A
	X Walk 1 Direction	To N		X Walk 2 Direction	N/A
N/A	X Walk 1 Width (in)	N/A	N/A	X Walk 2 Width (in)	N/A
	X Walk 1 Slope (%)	4.9		X Walk 2 Slope (%)	N/A
	X Walk 1 X Slope (%)	2.6		X Walk 2 X Slope (%)	N/A

N/A	Ramp inside XWalk1?	N/A	N/A	Ramp inside XWalk2?	N/A
	Road Slope (%)	N/A	N/A	Clear Space?	N/A
	Road X Slope (%)	N/A	N/A	Clear Space to XWalk (in)	N/A
N/A	Any Obstructions?	N/A	N/A	Storm Grate/Utility Hazard?	N/A
	Obstruction Type			Storm Grate/Utility Type	
		N/A			N/A
			Yes	Surface Condition? (G/P)	Good

Possible Solutions:

Remove & Replace Entire Ramp.

Total Cost: \$ 1850.00
