Access Compliance Report

Public Rights-of-Way

(Curb Ramps)

Intersection ID: 27719	Main Street: BREM_LN	Cross Street: FLENNIGAN_WY	Location: NW
ADA ID: 91DA86D04754	Ramp Type: Perp	Initial Pass/Fail: Fail	Overall Compliance: No
Severity Score: 25			
Codes/Mitigation Info/Possible Solution		Field Measurements/Component Compliance

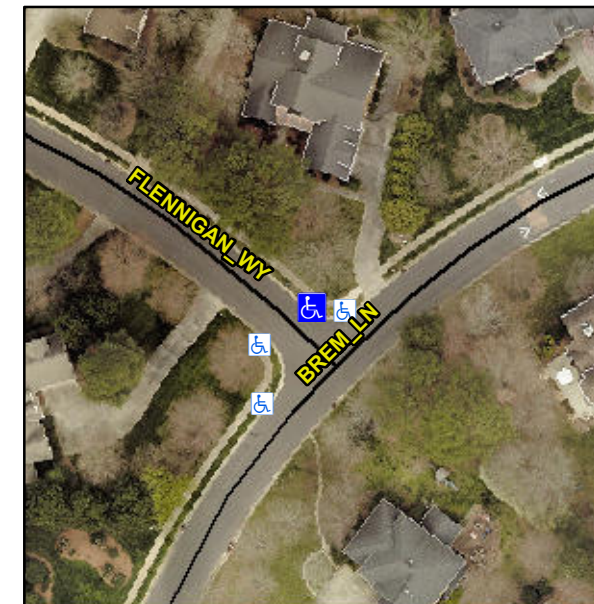
Not Found, R304.5.3

Compliance	Description	Data	Compliance	Description	Data
N/A	Ramp Length (in)	50.0	Yes	Ramp Slope (%)	3.9
Yes	Ramp Width (in)	48.0	No	Ramp XSlope (%)	9.2
N/A	Flare Type LT	N/A	N/A	Flare Type RT	N/A
N/A	Flare Slope LT (%)	N/A	N/A	Flare Slope RT (%)	N/A
N/A	Flare Traversable LT?	N/A	N/A	Flare Traversable RT?	N/A
N/A	Landing Length (in)	N/A	N/A	DWS Provided?	N/A
N/A	Landing Width (in)	N/A	N/A	DWS Contrast?	N/A
N/A	Landing Slope (%)	N/A	N/A	DWS Length (in)	N/A
N/A	Landing X Slope (%)	N/A	N/A	DWS Full Width?	N/A
N/A	Landing Curb? (Y/N)	N/A	N/A	DWS Offset (in)	N/A
N/A	Shared Landing?	N/A			
N/A	Gutter Ponding?	N/A	N/A	Gutter Slope (%)	N/A
N/A	Gutter Lip Ht (in)	N/A	N/A	Gutter X Slope (%)	N/A
N/A	Painted X Walk1?	No	N/A	Painted X Walk2?	N/A
	X Walk 1 Direction	To SW		X Walk 2 Direction	N/A
N/A	X Walk 1 Width (in)	N/A	N/A	X Walk 2 Width (in)	N/A
	X Walk 1 Slope (%)	0.3		X Walk 2 Slope (%)	N/A
	X Walk 1 X Slope (%)	3.6		X Walk 2 X Slope (%)	N/A

N/A	Ramp inside XWalk1?	N/A	N/A	Ramp inside XWalk2?	N/A
	Road Slope (%)	N/A	N/A	Clear Space?	N/A
	Road X Slope (%)	N/A	N/A	Clear Space to XWalk (in)	N/A
N/A	Any Obstructions?	N/A	N/A	Storm Grate/Utility Hazard?	N/A
	Obstruction Type			Storm Grate/Utility Type	
		N/A			N/A
			Yes	Surface Condition? (G/P)	Good

Possible Solutions:

Remove & Replace Entire Ramp.
