Access Compliance Report Public Rights-of-Way (Curb Ramps)

Intersection ID: 9255 Main Street: BOOKER_AV Cross Street: CAMPUS_ST Location: NE **ADA ID: 91E44FACDDCE** Ramp Type: PerpDiag Initial Pass/Fail: Fail **Overall Compliance: No Severity Score:** 47.5

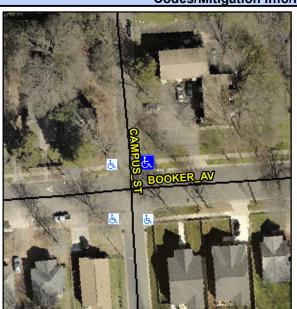
Field Measurements/Component Compliance					
Compliance Description		Data	Comp	liance Description	Data
N/A	Ramp Length (in)	59.5	Yes	Ramp Slope (%)	7.8
No	Ramp Width (in)	31.0	No	Ramp XSlope (%)	5.4
N/A	Flare Type LT	N/A	N/A	Flare Type RT	N/A
N/A	Flare Slope LT (%)	N/A	N/A	Flare Slope RT (%)	N/A
N/A	Flare Traversable LT?	N/A	N/A	Flare Traversable RT?	N/A
N/A	Landing Length (in)	N/A	N/A	DWS Provided?	N/A
N/A	Landing Width (in)	N/A	N/A	DWS Contrast?	N/A
N/A	Landing Slope (%)	N/A	N/A	DWS Length (in)	N/A
N/A	Landing X Slope (%)	N/A	N/A	DWS Full Width?	N/A
N/A	Landing Curb? (Y/N)	N/A	N/A	DWS Offset (in)	N/A
N/A	Shared Landing?	N/A			
N/A	Gutter Ponding?	N/A	N/A	Gutter Slope (%)	N/A
N/A	Gutter Lip Ht (in)	N/A	N/A	Gutter X Slope (%)	N/A
N/A	Painted X Walk1?	No	N/A	Painted X Walk2?	No
	X Walk 1 Direction	To W		X Walk 2 Direction	To S
N/A	X Walk 1 Width (in)	N/A	N/A	X Walk 2 Width (in)	N/A
	X Walk 1 Slope (%)	2.2		X Walk 2 Slope (%)	6.5

X Walk 1 X Slope (%)	3.8		X Walk 2 X Slope (%)	2.7
N/A	Ramp inside XWalk1?	N/A	N/A	Ramp inside XWalk2?	N/A
	Road Slope (%)	3.7	N/A	Clear Space?	N/A
	Road X Slope (%)	4.2	N/A	Clear Space to XWalk (in)	N/A
N/A	Any Obstructions?	N/A	N/A	Storm Grate/Utility Hazard?	N/A
	Obstruction Type			Storm Grate/Utility Type	
		N/A			N/A
			Yes	Surface Condition? (G/P)	Good

Possible Solutions: Remove & Replace Curb Ramp With **Two New Directional Ramps or** Equivalent. Surveyor Notes: N/A PROW/ADA: Not Found, R304.5.1, R304.5.3
