Access Compliance Report Public Rights-of-Way (Curb Ramps)

Intersection ID: 12298 Main Street: MILLERTON AV **Cross Street: MORTON ST** Location: NE Initial Pass/Fail: Fail **Overall Compliance: No ADA ID: 91ED4C37E14D** Ramp Type: BlendTrans1 Severity Score: 21.25

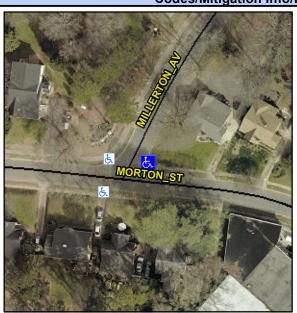
Ramp Length (in) Yes BlendTrans Slope (%) N/A 26.0 1.2 No No Ramp Width (in) 47.5 BlendTrans XSlope (%) 5.4 N/A N/A Flare Type LT N/A Flare Type RT N/A N/A Flare Slope LT (%) N/A N/A Flare Slope RT (%) N/A N/A Flare Traversable LT? N/A N/A Flare Traversable RT? N/A N/A Landing Length (in) N/A N/A **DWS Provided?** N/A N/A Landing Width (in) N/A N/A **DWS Contrast?** N/A N/A N/A N/A Landing Slope (%) DWS Length (in) N/A N/A Landing X Slope (%) N/A N/A DWS Full Width? N/A N/A Landing Curb? (Y/N) N/A N/A DWS Offset (in) N/A N/A N/A Shared Landing? N/A **Gutter Ponding?** N/A N/A Gutter Slope (%) N/A N/A Gutter Lip Ht (in) N/A N/A Gutter X Slope (%) N/A N/A Painted X Walk1? No N/A Painted X Walk2? N/A X Walk 1 Direction To W X Walk 2 Direction N/A N/A X Walk 1 Width (in) X Walk 2 Width (in) N/A X Walk 1 Slope (%) 4.2 X Walk 2 Slope (%) N/A X Walk 1 X Slope (%) 2.4 X Walk 2 X Slope (%) N/A N/A N/A Ramp inside XWalk2? N/A Ramp inside XWalk1? N/A Road Slope (%) 2.4 Clear Space? N/A Road X Slope (%) N/A Clear Space to XWalk (in) N/A 4.2 N/A N/A N/A Any Obstructions? Storm Grate/Utility Hazard? N/A **Obstruction Type** Storm Grate/Utility Type N/A N/A Yes Surface Condition? (G/P) Good No 5.8 Curb Slope (%)

MILLERTON AV Street 1 Name Stop Condition-Street 1 StopSign N/A Street 2 Name Stop Condition-Street 2 N/A Possible Solutions: Remove & Replace Curb Ramp With Two New Directional Ramps or Equivalent. Surveyor Notes: N/A Not Found, R304.5.1, R304.5.3
