# Access Compliance Report

## Public Rights-of-Way

### (Curb Ramps)

Intersection ID: 29709	Main Street: COLE_MILL_RD	Cross Street: LUTHERS_ROCK_CT	Location: S
ADA ID: 91F0885189CC	Ramp Type: PerpDiag	Initial Pass/Fail: Fail	Overall Compliance: No
Severity Score: 21.25			
Codes/Mitigation Info/Possible Solution		Field Measurements/Component Compliance

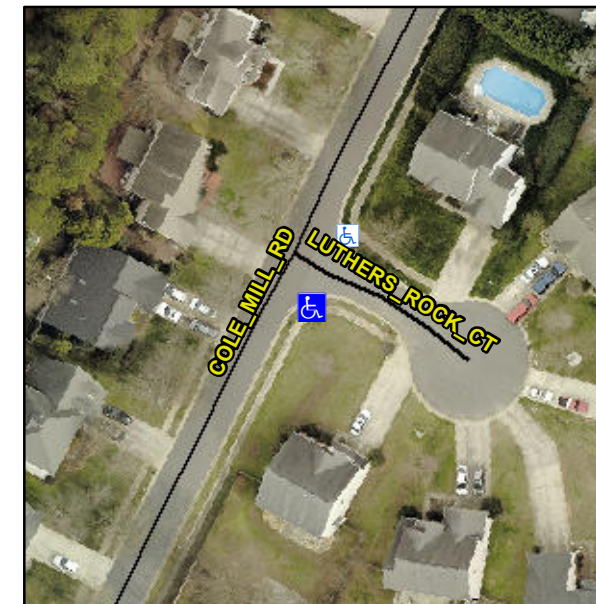
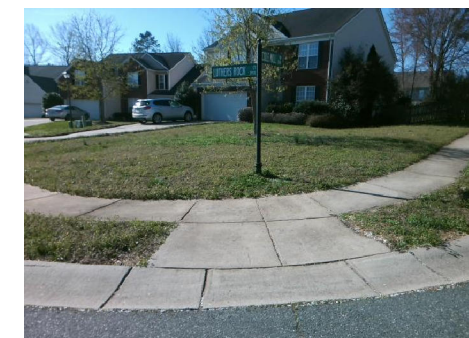
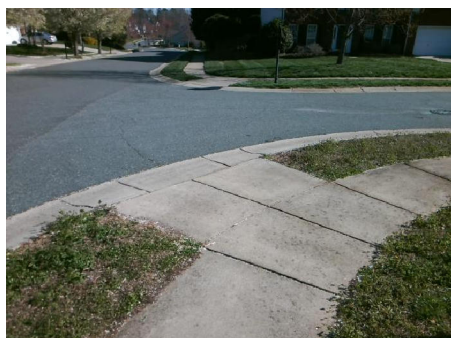
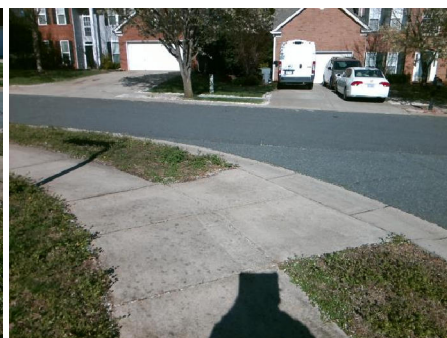
**R304.5.1, R304.5.3**

Compliance	Description	Data	Compliance	Description	Data
N/A	Ramp Length (in)	49.0	Yes	Ramp Slope (%)	5.1
No	Ramp Width (in)	47.0	No	Ramp XSlope (%)	5.7
N/A	Flare Type LT	N/A	N/A	Flare Type RT	N/A
N/A	Flare Slope LT (%)	N/A	N/A	Flare Slope RT (%)	N/A
N/A	Flare Traversable LT?	N/A	N/A	Flare Traversable RT?	N/A
N/A	Landing Length (in)	N/A	N/A	DWS Provided?	N/A
N/A	Landing Width (in)	N/A	N/A	DWS Contrast?	N/A
N/A	Landing Slope (%)	N/A	N/A	DWS Length (in)	N/A
N/A	Landing X Slope (%)	N/A	N/A	DWS Full Width?	N/A
N/A	Landing Curb? (Y/N)	N/A	N/A	DWS Offset (in)	N/A
N/A	Shared Landing?	N/A			
N/A	Gutter Ponding?	N/A	N/A	Gutter Slope (%)	N/A
N/A	Gutter Lip Ht (in)	N/A	N/A	Gutter X Slope (%)	N/A
N/A	Painted X Walk1?	No	N/A	Painted X Walk2?	No
	X Walk 1 Direction	To NE		X Walk 2 Direction	To NW
N/A	X Walk 1 Width (in)	N/A	N/A	X Walk 2 Width (in)	N/A
	X Walk 1 Slope (%)	2.6		X Walk 2 Slope (%)	5.2
	X Walk 1 X Slope (%)	1.7		X Walk 2 X Slope (%)	2.8

N/A	Ramp inside XWalk1?	N/A	N/A	Ramp inside XWalk2?	N/A
	Road Slope (%)	5.9	N/A	Clear Space?	N/A
	Road X Slope (%)	0.5	N/A	Clear Space to XWalk (in)	N/A
N/A	Any Obstructions?	N/A	N/A	Storm Grate/Utility Hazard?	N/A
	Obstruction Type			Storm Grate/Utility Type	
		N/A			N/A
			Yes	Surface Condition? (G/P)	Good

**Remove & Replace Curb Ramp With Two New Directional Ramps or Equivalent.**

Total Cost: \$ 3200.00
