Access Compliance Report

(Curb Ramps)

Intersection ID: 10024872	Main Street: DEWITT_LN	Cross Street: N/A	Location: SE
ADA ID: 91F2DCE878B7	Ramp Type: Perp	Initial Pass/Fail: Fail	Overall Compliance: No
		Severity Score: 8.75

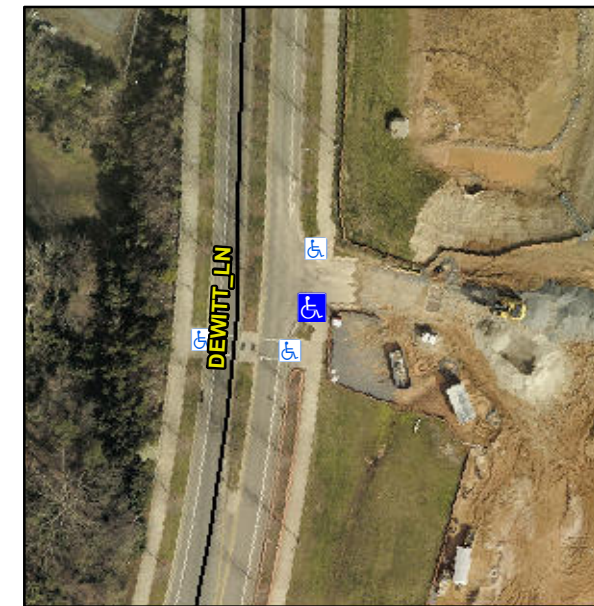
Not Found, R304.5.1

Compliance	Description	Data	Compliance	Description	Data
N/A	Ramp Length (in)	96.0	Yes	Ramp Slope (%)	7.0
No	Ramp Width (in)	42.0	Yes	Ramp XSlope (%)	0.3
N/A	Flare Type LT	N/A	N/A	Flare Type RT	N/A
N/A	Flare Slope LT (%)	N/A	N/A	Flare Slope RT (%)	N/A
N/A	Flare Traversable LT?	N/A	N/A	Flare Traversable RT?	N/A
N/A	Landing Length (in)	N/A	N/A	DWS Provided?	N/A
N/A	Landing Width (in)	N/A	N/A	DWS Contrast?	N/A
N/A	Landing Slope (%)	N/A	N/A	DWS Length (in)	N/A
N/A	Landing X Slope (%)	N/A	N/A	DWS Full Width?	N/A
N/A	Landing Curb? (Y/N)	N/A	N/A	DWS Offset (in)	N/A
N/A	Shared Landing?	N/A			
N/A	Gutter Ponding?	N/A	N/A	Gutter Slope (%)	N/A
N/A	Gutter Lip Ht (in)	N/A	N/A	Gutter X Slope (%)	N/A
N/A	Painted X Walk1?	No	N/A	Painted X Walk2?	N/A
	X Walk 1 Direction	To N		X Walk 2 Direction	N/A
N/A	X Walk 1 Width (in)	N/A	N/A	X Walk 2 Width (in)	N/A
	X Walk 1 Slope (%)	2.3		X Walk 2 Slope (%)	N/A
	X Walk 1 X Slope (%)	0.1		X Walk 2 X Slope (%)	N/A

N/A	Ramp inside XWalk1?	N/A	N/A	Ramp inside XWalk2?	N/A
	Road Slope (%)	N/A	N/A	Clear Space?	N/A
	Road X Slope (%)	N/A	N/A	Clear Space to XWalk (in)	N/A
N/A	Any Obstructions?	N/A	N/A	Storm Grate/Utility Hazard?	N/A
	Obstruction Type			Storm Grate/Utility Type	
		N/A			N/A
			Yes	Surface Condition? (G/P)	Good

Possible Solutions:

Remove & Replace Entire Ramp.
