Access Compliance Report

Public Rights-of-Way

(Curb Ramps)

Intersection ID: 10036062	Main Street: RIVERGATE_PY	Cross Street: N/A	Location: E
ADA ID: 91FCCED0132C	Ramp Type: PerpDiag	Initial Pass/Fail: Pass	Overall Compliance: No
		Severity Score: 0.25

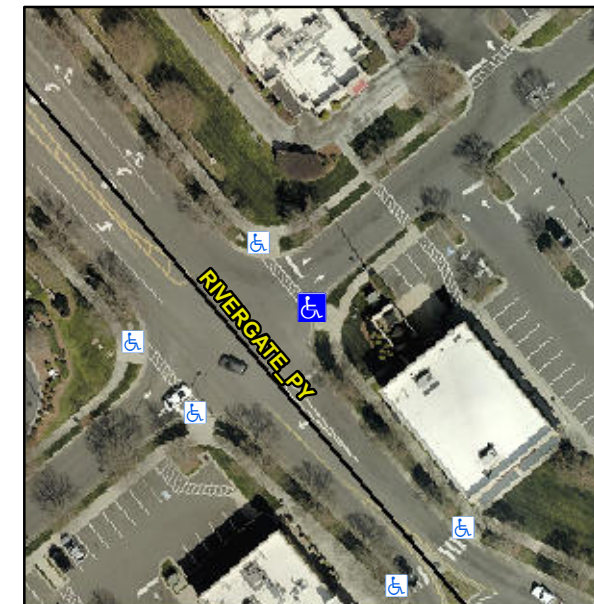
Not Found, R304.5.3, R304.2.2-Perp, R304.3.2-Para

Compliance	Description	Data	Compliance	Description	Data
N/A	Ramp Length (in)	97.0	Yes	Ramp Slope (%)	7.5
Yes	Ramp Width (in)	48.0	No	Ramp XSlope (%)	2.3
N/A	Flare Type LT	Sloped	N/A	Flare Type RT	N/A
N/A	Flare Slope LT (%)	5.0	N/A	Flare Slope RT (%)	7.6
N/A	Flare Traversable LT?	No	N/A	Flare Traversable RT?	No
Yes	Landing Length (in)	71.0	Yes	DWS Provided?	Yes
Yes	Landing Width (in)	48.8	Yes	DWS Contrast?	Yes
No	Landing Slope (%)	2.9	Yes	DWS Length (in)	24.5
Yes	Landing X Slope (%)	2.0	Yes	DWS Full Width?	Yes
N/A	Landing Curb? (Y/N)	No	Yes	DWS Offset (in)	1.0
N/A	Shared Landing?	No			
Yes	Gutter Ponding?	No	Yes	Gutter Slope (%)	4.4
Yes	Gutter Lip Ht (in)	0.0	No	Gutter X Slope (%)	2.1
N/A	Painted X Walk1?	Yes	N/A	Painted X Walk2?	No
	X Walk 1 Direction	To N		X Walk 2 Direction	To W
N/A	X Walk 1 Width (in)	52.0	N/A	X Walk 2 Width (in)	N/A
	X Walk 1 Slope (%)	1.3		X Walk 2 Slope (%)	1.4
	X Walk 1 X Slope (%)	2.2		X Walk 2 X Slope (%)	1.4

Yes	Ramp inside XWalk1?	Yes	N/A	Ramp inside XWalk2?	N/A
	Road Slope (%)	1.8	N/A	Clear Space?	Yes
	Road X Slope (%)	2.6	N/A	Clear Space to XWalk (in)	23.0
Yes	Any Obstructions?	No	Yes	Storm Grate/Utility Hazard?	No
	Obstruction Type			Storm Grate/Utility Type	
			N/A		N/A
			Yes	Surface Condition? (G/P)	Good

Remove & Replace Curb Ramp With Two New Directional Ramps or Equivalent. Remove & Replace Gutter.
