# Access Compliance Report

## Public Rights-of-Way

### (Curb Ramps)

Intersection ID: 49102	Main Street: PROSPERITY_CROSSING_DR	Cross Street: BENFIELD_RD	Location: S
ADA ID: 91FFE56EF041	Ramp Type: BlendTrans1	Initial Pass/Fail: Pass	Overall Compliance: No
Severity Score: 0.25			
Codes/Mitigation Info/Possible Solution		Field Measurements/Component Compliance

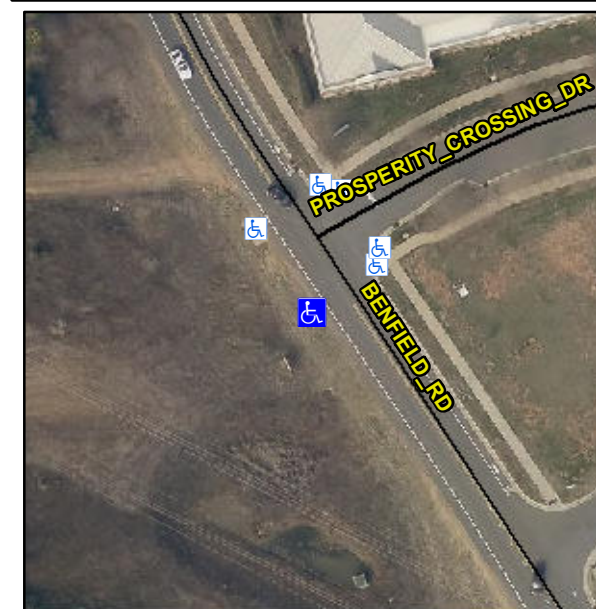
**NO CURB, NO SW, DWS OS MEASURED TO ASP**

Compliance	Description	Data	Compliance	Description	Data
N/A	Ramp Length (in)	49.0	Yes	BlendTrans Slope (%)	4.3
Yes	Ramp Width (in)	48.0	No	BlendTrans XSlope (%)	2.1
N/A	Flare Type LT	Sloped	N/A	Flare Type RT	Sloped
N/A	Flare Slope LT (%)	N/A	N/A	Flare Slope RT (%)	N/A
N/A	Flare Traversable LT?	No	N/A	Flare Traversable RT?	No
No	Landing Length (in)	47.0	Yes	DWS Provided?	Yes
Yes	Landing Width (in)	48.0	Yes	DWS Contrast?	Yes
No	Landing Slope (%)	2.2	Yes	DWS Length (in)	24.0
Yes	Landing X Slope (%)	1.8	Yes	DWS Full Width?	Yes
N/A	Landing Curb? (Y/N)	No	No	DWS Offset (in)	5.0
N/A	Shared Landing?	No			
Yes	Gutter Ponding?	No	Yes	Gutter Slope (%)	2.5
Yes	Gutter Lip Ht (in)	0.0	Yes	Gutter X Slope (%)	1.8
N/A	Painted X Walk1?	No	N/A	Painted X Walk2?	N/A
	X Walk 1 Direction	To NE		X Walk 2 Direction	N/A
	X Walk 1 Width (in)	N/A		X Walk 2 Width (in)	N/A
	X Walk 1 Slope (%)	2.5		X Walk 2 Slope (%)	N/A
	X Walk 1 X Slope (%)	1.8		X Walk 2 X Slope (%)	N/A

N/A	Ramp inside XWalk1?	N/A	N/A	Ramp inside XWalk2?	N/A
	Road Slope (%)	1.8		Clear Space?	Yes
	Road X Slope (%)	2.5	N/A	Clear Space to XWalk (in)	N/A
Yes	Any Obstructions?	No	Yes	Storm Grate/Utility Hazard?	No
	Obstruction Type			Storm Grate/Utility Type	
		N/A			N/A
			Yes	Surface Condition? (G/P)	Good
			N/A	Curb Slope (%)	N/A

Possible Solutions:

**Remove & Replace Curb Ramp With Two New Directional Ramps or Equivalent.**

Total Cost: \$ 3200.00
