Access Compliance Report

Public Rights-of-Way

(Curb Ramps)

Intersection ID: N/A	Main Street: SARDIS_RD_NORTH	Cross Street: N/A	Location: N
ADA ID: 920609BB3851	Ramp Type: Para	Initial Pass/Fail: Fail	Overall Compliance: No
Codes/Mitigation Info/Possible Solution		Field Measurements/Component Compliance	
Severity Score: 12.5

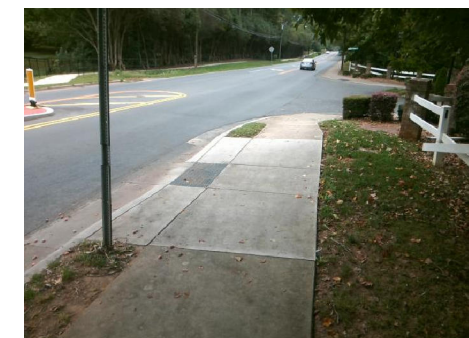
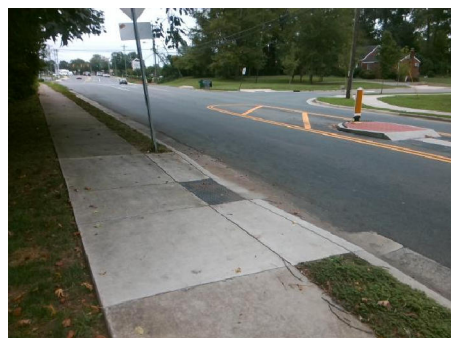
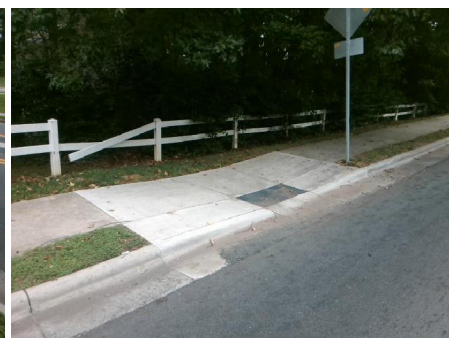
Compliance	Description	Data	Compliance	Description	Data
N/A	Ramp Length LT (in)	70.0	N/A	Ramp Length RT (in)	69.0
Yes	Ramp Width LT (in)	61.0	Yes	Ramp Width RT (in)	60.0
Yes	Ramp Slope LT (%)	5.5	No	Ramp Slope RT (%)	8.5
Yes	Ramp XSlope LT (%)	1.6	Yes	Ramp XSlope RT (%)	1.6
N/A	Landing Length (in)	N/A	N/A	DWS Provided?	N/A
N/A	Landing Width (in)	N/A	N/A	DWS Contrast?	N/A
N/A	Landing Slope (%)	N/A	N/A	DWS Length (in)	N/A
N/A	Landing X Slope (%)	N/A	N/A	DWS Full Width?	N/A
N/A	Landing Curb? (Y/N)	N/A	N/A	DWS Offset (in)	N/A
N/A	Shared Landing?	N/A			
N/A	Gutter Ponding?	N/A	N/A	Gutter Slope (%)	N/A
N/A	Gutter Lip Ht (in)	N/A	N/A	Gutter X Slope (%)	N/A
N/A	Painted X Walk1?	No	N/A	Painted X Walk2?	N/A
	X Walk 1 Direction	To SE		X Walk 2 Direction	N/A
N/A	X Walk 1 Width (in)	N/A	N/A	X Walk 2 Width (in)	N/A
	X Walk 1 Slope (%)	5.6		X Walk 2 Slope (%)	N/A
	X Walk 1 X Slope (%)	1.1		X Walk 2 X Slope (%)	N/A
N/A	Ramp inside XWalk1?	N/A	N/A	Ramp inside XWalk2?	N/A

Road Slope (%)	N/A	N/A	Clear Space?	N/A
	Road X Slope (%)	N/A	N/A	Clear Space to XWalk (in)	N/A
N/A	Any Obstructions?	N/A	N/A	Storm Grate/Utility Hazard?	N/A
	Obstruction Type			Storm Grate/Utility Type	
		N/A			N/A
			Yes	Surface Condition? (G/P)	Good
			N/A	Curb Slope (%)	10.7

Possible Solutions:

Remove & Replace Entire Ramp.

PROW/ADA:

R304.3.2
