## Access Compliance Report Public Rights-of-Way (Curb Ramps)

Intersection ID: 29414 Main Street: LINDA\_LAKE\_DR Cross Street: POSSUM\_TROT\_LN Location: E

ADA ID: 920FF6E81FEB Ramp Type: BlendTrans1 Initial Pass/Fail: Fail Overall Compliance: No Severity Score: 8.75

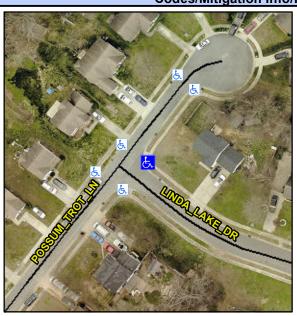
Not Found, R304.5.1

ried Measurements/Component Compliance					
Compliance Description		Data	Compliance Description		Data
N/A	Ramp Length (in)	46.0	Yes	BlendTrans Slope (%)	3.6
No	Ramp Width (in)	47.5	Yes	BlendTrans XSlope (%)	1.5
N/A	Flare Type LT	N/A	N/A	Flare Type RT	N/A
N/A	Flare Slope LT (%)	N/A	N/A	Flare Slope RT (%)	N/A
N/A	Flare Traversable LT?	N/A	N/A	Flare Traversable RT?	N/A
N/A	Landing Length (in)	N/A	N/A	DWS Provided?	N/A
N/A	Landing Width (in)	N/A	N/A	DWS Contrast?	N/A
N/A	Landing Slope (%)	N/A	N/A	DWS Length (in)	N/A
N/A	Landing X Slope (%)	N/A	N/A	DWS Full Width?	N/A
N/A	Landing Curb? (Y/N)	N/A	N/A	DWS Offset (in)	N/A
N/A	Shared Landing?	N/A			
N/A	Gutter Ponding?	N/A	N/A	Gutter Slope (%)	N/A
N/A	Gutter Lip Ht (in)	N/A	N/A	Gutter X Slope (%)	N/A
N/A	Painted X Walk1?	No	N/A	Painted X Walk2?	No
	X Walk 1 Direction	To NW		X Walk 2 Direction	To SW
	X Walk 1 Width (in)	N/A		X Walk 2 Width (in)	N/A
	X Walk 1 Slope (%)	3.4		X Walk 2 Slope (%)	0.4

X Walk 1 X Slope (%)	0.3		X Walk 2 X Slope (%)	1.2
N/A	Ramp inside XWalk1?	N/A	N/A	Ramp inside XWalk2?	N/A
	Road Slope (%)	0.4		Clear Space?	N/A
	Road X Slope (%)	2.0	N/A	Clear Space to XWalk (in)	N/A
N/A	Any Obstructions?	N/A	N/A	Storm Grate/Utility Hazard?	N/A
	Obstruction Type			Storm Grate/Utility Type	
		N/A			N/A

Remove & Replace Curb Ramp With Two New Directional Ramps or Equivalent.

Total Cost: \$ 3200.00
