# Access Compliance Report

## Public Rights-of-Way

### (Curb Ramps)

| Intersection ID: 3595 | Main Street: CLAIBORNE_WOODS_RD | Cross Street: TARPAN_CT | Location: | W |

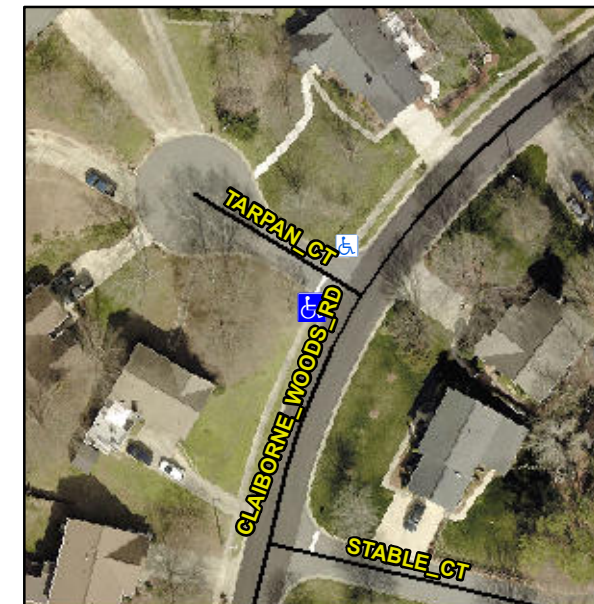
| ADA ID: 9214404155F4 | Ramp Type: Perp | Initial Pass/Fail: Fail | Overall Compliance: No | Severity Score: 1.25 |

**Not Found, R304.5.3**

| Compliance | Description | Data | Compliance | Description | Data |
|---|---|---|---|---|---|
| N/A | Ramp Length (in) | 25.5 | Yes | Ramp Slope (%) | 5.0 |
| Yes | Ramp Width (in) | 48.0 | No | Ramp XSlope (%) | 3.8 |

**Remove & Replace Entire Ramp.**

Total Cost: \$ 1850.00
