Access Compliance Report

Public Rights-of-Way

(Curb Ramps)

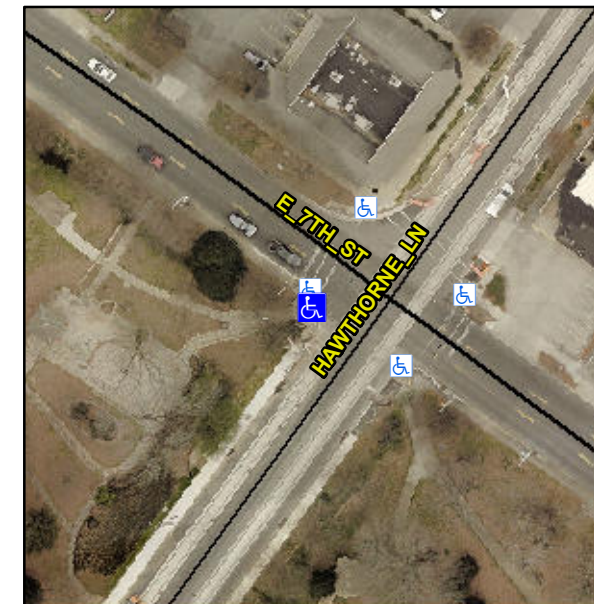
Intersection ID: 13667	Main Street: E_7TH_ST	Cross Street: HAWTHORNE_LN	Location: W
ADA ID: 921AF9A9A23A	Ramp Type: Perp	Initial Pass/Fail: Fail	Overall Compliance: No
Severity Score: 13.75			
Codes/Mitigation Info/Possible Solution		Field Measurements/Component Compliance

Compliance	Description	Data	Compliance	Description	Data
N/A	Ramp Length (in)	68.0	No	Ramp Slope (%)	8.8
Yes	Ramp Width (in)	48.0	No	Ramp XSlope (%)	2.4
N/A	Flare Type LT	N/A	N/A	Flare Type RT	N/A
N/A	Flare Slope LT (%)	N/A	N/A	Flare Slope RT (%)	N/A
N/A	Flare Traversable LT?	N/A	N/A	Flare Traversable RT?	N/A
N/A	Landing Length (in)	N/A	N/A	DWS Provided?	N/A
N/A	Landing Width (in)	N/A	N/A	DWS Contrast?	N/A
N/A	Landing Slope (%)	N/A	N/A	DWS Length (in)	N/A
N/A	Landing X Slope (%)	N/A	N/A	DWS Full Width?	N/A
N/A	Landing Curb? (Y/N)	N/A	N/A	DWS Offset (in)	N/A
N/A	Shared Landing?	N/A			
N/A	Gutter Ponding?	N/A	N/A	Gutter Slope (%)	N/A
N/A	Gutter Lip Ht (in)	N/A	N/A	Gutter X Slope (%)	N/A
N/A	Painted X Walk1?	Yes	N/A	Painted X Walk2?	N/A
	X Walk 1 Direction	To SE		X Walk 2 Direction	N/A
N/A	X Walk 1 Width (in)	109.0	N/A	X Walk 2 Width (in)	N/A
	X Walk 1 Slope (%)	2.6		X Walk 2 Slope (%)	N/A
	X Walk 1 X Slope (%)	1.6		X Walk 2 X Slope (%)	N/A

N/A	Ramp inside XWalk1?	Yes	N/A	Ramp inside XWalk2?	N/A
	Road Slope (%)	N/A	N/A	Clear Space?	N/A
	Road X Slope (%)	N/A	N/A	Clear Space to XWalk (in)	N/A
N/A	Any Obstructions?	N/A	N/A	Storm Grate/Utility Hazard?	N/A
	Obstruction Type			Storm Grate/Utility Type	
		N/A			N/A
			Yes	Surface Condition? (G/P)	Good

Possible Solutions:

Remove & Replace Entire Ramp.

R304.2.2, R304.5.3
