| Intersection ID: 13413 | Main Street: OLD_STEELE_CREEK_RD | Cross Street: SEYMOUR_DR | Location: | NW |
| ADA ID: 9222F5A364DC | Ramp Type: ParaDiag | Initial Pass/Fail: Fail | Overall Compliance: No | Severity Score: 13.75 |

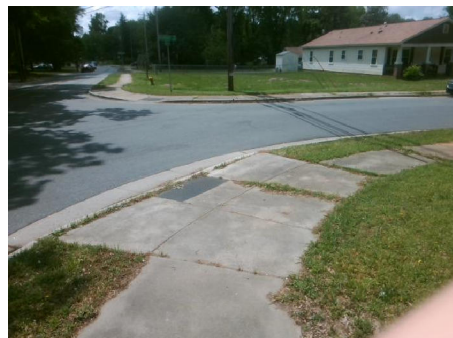
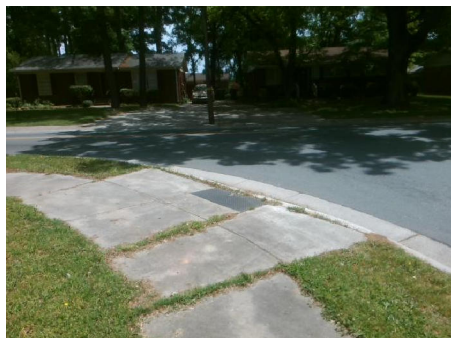
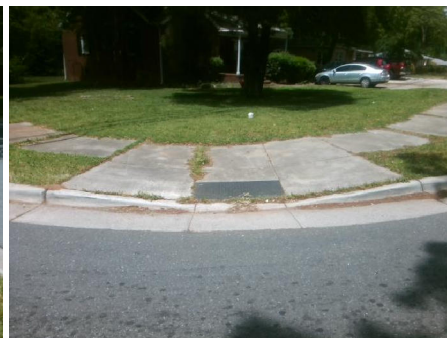
LT RP < 5%

| Compliance | Description | Data | Compliance | Description | Data |
|---|---|---|---|---|---|
| Yes | Ramp Slope LT (%) | 2.8 | No | Ramp Slope RT (%) | 8.7 |
| Yes | Ramp XSlope LT (%) | 1.4 | No | Ramp XSlope RT (%) | 2.3 |

Remove & Replace Curb Ramp With Two New Directional Ramps or Equivalent.
