Access Compliance Report

Public Rights-of-Way

(Curb Ramps)

Intersection ID: 53979	Main Street: MESHACK_AV	Cross Street: CASRACK_ST	Location:	E
ADA ID: 922572AEC30E	Ramp Type: Perp	Initial Pass/Fail: Fail	Overall Compliance: No	Severity Score: 10
Codes/Mitigation Info/Possible Solution		Field Measurements/Component Compliance

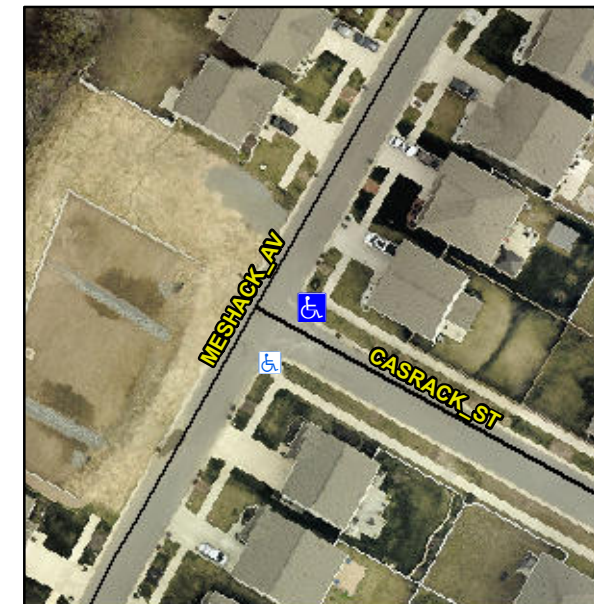
Not Found, R304.5.1, R304.5.3

Compliance	Description	Data	Compliance	Description	Data
N/A	Ramp Length (in)	104.0	Yes	Ramp Slope (%)	5.4
No	Ramp Width (in)	46.0	No	Ramp XSlope (%)	3.0
N/A	Flare Type LT	N/A	N/A	Flare Type RT	N/A
N/A	Flare Slope LT (%)	N/A	N/A	Flare Slope RT (%)	N/A
N/A	Flare Traversable LT?	N/A	N/A	Flare Traversable RT?	N/A
N/A	Landing Length (in)	N/A	N/A	DWS Provided?	N/A
N/A	Landing Width (in)	N/A	N/A	DWS Contrast?	N/A
N/A	Landing Slope (%)	N/A	N/A	DWS Length (in)	N/A
N/A	Landing X Slope (%)	N/A	N/A	DWS Full Width?	N/A
N/A	Landing Curb? (Y/N)	N/A	N/A	DWS Offset (in)	N/A
N/A	Shared Landing?	N/A			
N/A	Gutter Ponding?	N/A	N/A	Gutter Slope (%)	N/A
N/A	Gutter Lip Ht (in)	2.0	N/A	Gutter X Slope (%)	N/A
N/A	Painted X Walk1?	No	N/A	Painted X Walk2?	N/A
	X Walk 1 Direction	To S		X Walk 2 Direction	N/A
N/A	X Walk 1 Width (in)	N/A	N/A	X Walk 2 Width (in)	N/A
	X Walk 1 Slope (%)	0.4		X Walk 2 Slope (%)	N/A
	X Walk 1 X Slope (%)	2.6		X Walk 2 X Slope (%)	N/A

N/A	Ramp inside XWalk1?	N/A	N/A	Ramp inside XWalk2?	N/A
	Road Slope (%)	N/A	N/A	Clear Space?	N/A
	Road X Slope (%)	N/A	N/A	Clear Space to XWalk (in)	N/A
N/A	Any Obstructions?	N/A	N/A	Storm Grate/Utility Hazard?	N/A
	Obstruction Type			Storm Grate/Utility Type	
		N/A			N/A
			Yes	Surface Condition? (G/P)	Good

Possible Solutions:

Remove & Replace Entire Ramp.
