Access Compliance Report

Public Rights-of-Way

(Curb Ramps)

Intersection ID: 14556	Main Street: E_WORTHINGTON_AV	Cross Street: WINTHROP_AV	Location: E
ADA ID: 9229418D8555	Ramp Type: Perp	Initial Pass/Fail: Fail	Overall Compliance: No
Severity Score: 26.25			
Codes/Mitigation Info/Possible Solution		Field Measurements/Component Compliance

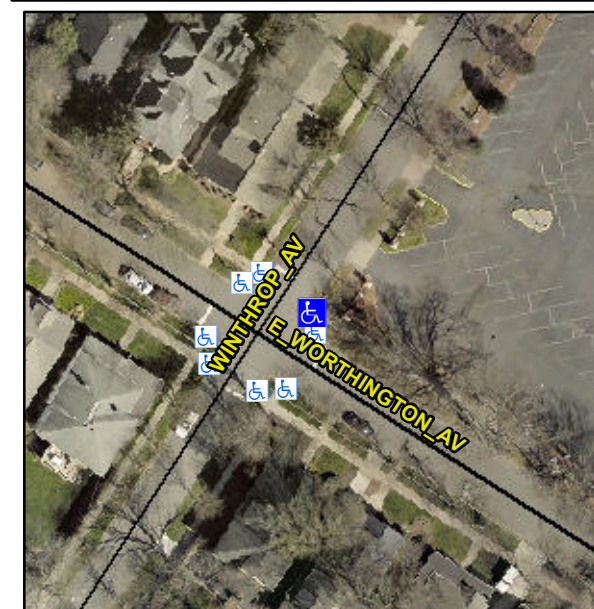
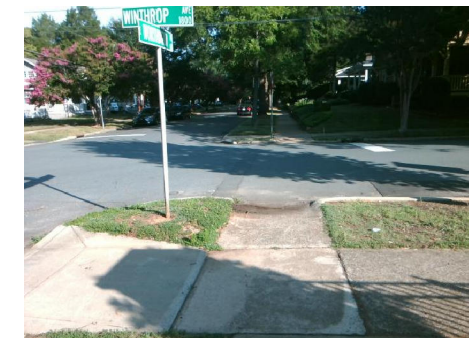
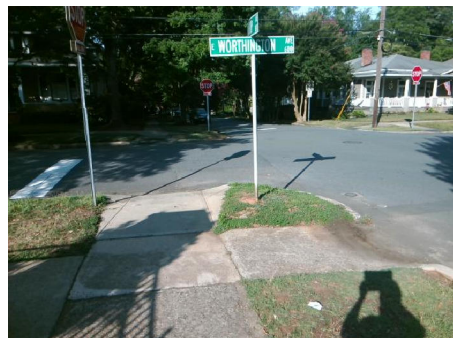
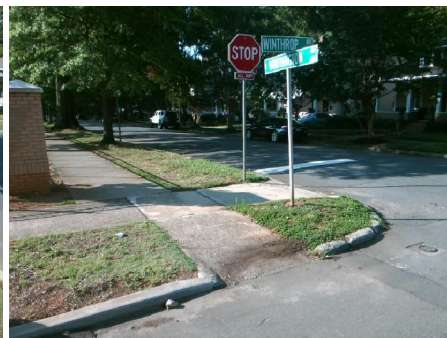
R304.2.2, R304.5.3

Compliance	Description	Data	Compliance	Description	Data
N/A	Ramp Length (in)	48.0	No	Ramp Slope (%)	12.0
Yes	Ramp Width (in)	48.0	No	Ramp XSlope (%)	3.2
N/A	Flare Type LT	N/A	N/A	Flare Type RT	N/A
N/A	Flare Slope LT (%)	N/A	N/A	Flare Slope RT (%)	N/A
N/A	Flare Traversable LT?	N/A	N/A	Flare Traversable RT?	N/A
N/A	Landing Length (in)	N/A	N/A	DWS Provided?	N/A
N/A	Landing Width (in)	N/A	N/A	DWS Contrast?	N/A
N/A	Landing Slope (%)	N/A	N/A	DWS Length (in)	N/A
N/A	Landing X Slope (%)	N/A	N/A	DWS Full Width?	N/A
N/A	Landing Curb? (Y/N)	N/A	N/A	DWS Offset (in)	N/A
N/A	Shared Landing?	N/A			
N/A	Gutter Ponding?	Yes	N/A	Gutter Slope (%)	N/A
N/A	Gutter Lip Ht (in)	1.0	N/A	Gutter X Slope (%)	N/A
N/A	Painted X Walk1?	No	N/A	Painted X Walk2?	N/A
	X Walk 1 Direction	To NW		X Walk 2 Direction	N/A
N/A	X Walk 1 Width (in)	N/A	N/A	X Walk 2 Width (in)	N/A
	X Walk 1 Slope (%)	4.7		X Walk 2 Slope (%)	N/A
	X Walk 1 X Slope (%)	0.8		X Walk 2 X Slope (%)	N/A

N/A	Ramp inside XWalk1?	N/A	N/A	Ramp inside XWalk2?	N/A
	Road Slope (%)	N/A	N/A	Clear Space?	N/A
	Road X Slope (%)	N/A	N/A	Clear Space to XWalk (in)	N/A
N/A	Any Obstructions?	N/A	N/A	Storm Grate/Utility Hazard?	N/A
	Obstruction Type			Storm Grate/Utility Type	
		N/A			N/A
		Yes		Surface Condition? (G/P)	Good

Remove & Replace Entire Ramp.
