Access Compliance Report

Public Rights-of-Way

(Curb Ramps)

Intersection ID: 2778	Main Street: HIGHLAND_CREEK_PY	Cross Street: BRADWELL_DR	Location: S
ADA ID: 922E9C586E2E	Ramp Type: PerpDiag	Initial Pass/Fail: Pass	Overall Compliance: No
Severity Score: 2.75			
Codes/Mitigation Info/Possible Solution		Field Measurements/Component Compliance

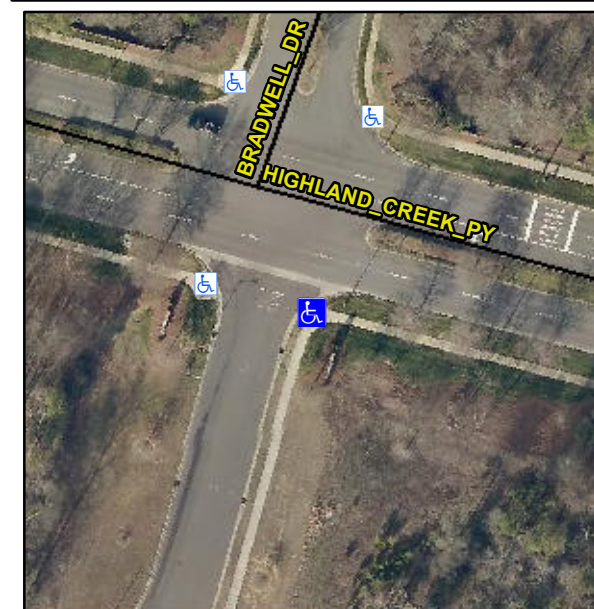
Compliance	Description	Data	Compliance	Description	Data
N/A	Ramp Length (in)	69.0	Yes	Ramp Slope (%)	7.7
Yes	Ramp Width (in)	48.0	No	Ramp XSlope (%)	3.5
N/A	Flare Type LT	Sloped	N/A	Flare Type RT	N/A
N/A	Flare Slope LT (%)	2.9	No	Flare Slope RT (%)	10.9
N/A	Flare Traversable LT?	Yes	N/A	Flare Traversable RT?	Yes
Yes	Landing Length (in)	60.0	Yes	DWS Provided?	Yes
Yes	Landing Width (in)	48.0	Yes	DWS Contrast?	Yes
No	Landing Slope (%)	2.5	Yes	DWS Length (in)	24.0
No	Landing X Slope (%)	3.6	Yes	DWS Full Width?	Yes
N/A	Landing Curb? (Y/N)	No	Yes	DWS Offset (in)	1.0
N/A	Shared Landing?	No			
Yes	Gutter Ponding?	No	Yes	Gutter Slope (%)	1.3
Yes	Gutter Lip Ht (in)	0.0	No	Gutter X Slope (%)	4.3
N/A	Painted X Walk1?	No	N/A	Painted X Walk2?	No
	X Walk 1 Direction	To NE		X Walk 2 Direction	To NW
N/A	X Walk 1 Width (in)	N/A	N/A	X Walk 2 Width (in)	N/A
	X Walk 1 Slope (%)	8.6		X Walk 2 Slope (%)	2.7
	X Walk 1 X Slope (%)	1.4		X Walk 2 X Slope (%)	7.2

N/A	Ramp inside XWalk1?	N/A	N/A	Ramp inside XWalk2?	N/A
	Road Slope (%)	4.8	N/A	Clear Space?	Yes
	Road X Slope (%)	7.1	N/A	Clear Space to XWalk (in)	N/A
Yes	Any Obstructions?	No	Yes	Storm Grate/Utility Hazard?	No
	Obstruction Type			Storm Grate/Utility Type	
		N/A			N/A
			Yes	Surface Condition? (G/P)	Good

Remove & Replace Curb Ramp With Two New Directional Ramps or Equivalent. Remove & Replace Gutter.
