# Access Compliance Report

## Public Rights-of-Way

### (Curb Ramps)

Intersection ID: N/A	Main Street: E_STONEWALL_ST	Cross Street: S_CALDWELL_ST	Location: NW
ADA ID: 923200035CC4	Ramp Type: Perp	Initial Pass/Fail: Fail	Overall Compliance: No
		Severity Score: 8.75	
Codes/Mitigation Info/Possible Solution		Field Measurements/Component Compliance

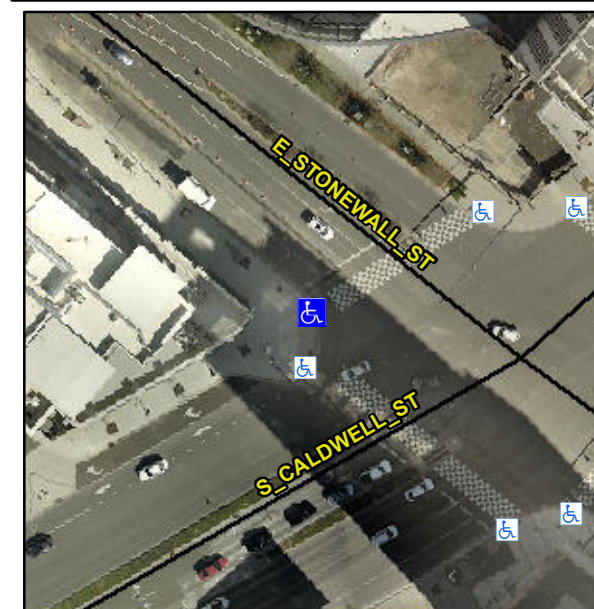
Compliance	Description	Data	Compliance	Description	Data
N/A	Ramp Length (in)	98.0	Yes	Ramp Slope (%)	5.4
No	Ramp Width (in)	43.5	Yes	Ramp XSlope (%)	1.0
N/A	Flare Type LT	N/A	N/A	Flare Type RT	N/A
N/A	Flare Slope LT (%)	N/A	N/A	Flare Slope RT (%)	N/A
N/A	Flare Traversable LT?	No	N/A	Flare Traversable RT?	No
N/A	Landing Length (in)	N/A	N/A	DWS Provided?	N/A
N/A	Landing Width (in)	N/A	N/A	DWS Contrast?	N/A
N/A	Landing Slope (%)	N/A	N/A	DWS Length (in)	N/A
N/A	Landing X Slope (%)	N/A	N/A	DWS Full Width?	N/A
N/A	Landing Curb? (Y/N)	N/A	N/A	DWS Offset (in)	N/A
N/A	Shared Landing?	N/A			
N/A	Gutter Ponding?	N/A	N/A	Gutter Slope (%)	N/A
N/A	Gutter Lip Ht (in)	N/A	N/A	Gutter X Slope (%)	N/A
N/A	Painted X Walk1?	Yes	N/A	Painted X Walk2?	N/A
	X Walk 1 Direction	To E		X Walk 2 Direction	N/A
N/A	X Walk 1 Width (in)	144.0	N/A	X Walk 2 Width (in)	N/A
	X Walk 1 Slope (%)	2.8		X Walk 2 Slope (%)	N/A
	X Walk 1 X Slope (%)	1.9		X Walk 2 X Slope (%)	N/A

N/A	Ramp inside XWalk1?	Yes	N/A	Ramp inside XWalk2?	N/A
	Road Slope (%)	N/A	N/A	Clear Space?	N/A
	Road X Slope (%)	N/A	N/A	Clear Space to XWalk (in)	N/A
N/A	Any Obstructions?	N/A	N/A	Storm Grate/Utility Hazard?	N/A
	Obstruction Type			Storm Grate/Utility Type	
		N/A			N/A
			Yes	Surface Condition? (G/P)	Good

Possible Solutions:

**Remove & Replace Entire Ramp.**

**Not Found, R304.5.1**

Total Cost: \$ 1850.00
