Access Compliance Report

Public Rights-of-Way

(Curb Ramps)

Intersection ID: N/A	Main Street: DEER TRAIL LN	Cross Street: FOX_COVE_DR	Location: SE
ADA ID: 923BA1FC9A3A	Ramp Type: Perp	Initial Pass/Fail: Fail	Overall Compliance: No
		Severity Score: 30

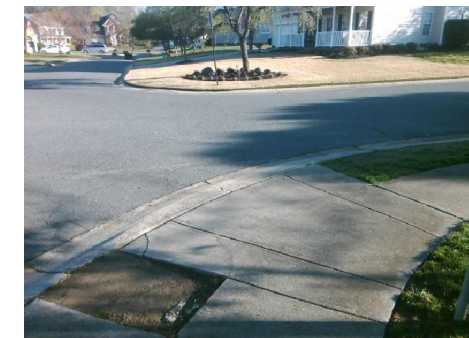
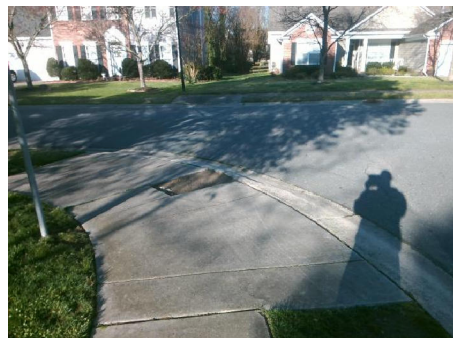
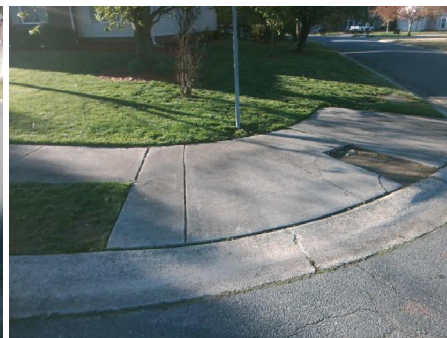
Not Found, R304.5.1, R304.5.3

Compliance	Description	Data	Compliance	Description	Data
N/A	Ramp Length (in)	97.0	Yes	Ramp Slope (%)	6.5
No	Ramp Width (in)	35.0	No	Ramp XSlope (%)	6.9
N/A	Flare Type LT	N/A	N/A	Flare Type RT	N/A
N/A	Flare Slope LT (%)	N/A	N/A	Flare Slope RT (%)	N/A
N/A	Flare Traversable LT?	N/A	N/A	Flare Traversable RT?	N/A
N/A	Landing Length (in)	N/A	N/A	DWS Provided?	N/A
N/A	Landing Width (in)	N/A	N/A	DWS Contrast?	N/A
N/A	Landing Slope (%)	N/A	N/A	DWS Length (in)	N/A
N/A	Landing X Slope (%)	N/A	N/A	DWS Full Width?	N/A
N/A	Landing Curb? (Y/N)	N/A	N/A	DWS Offset (in)	N/A
N/A	Shared Landing?	N/A			
N/A	Gutter Ponding?	N/A	N/A	Gutter Slope (%)	N/A
N/A	Gutter Lip Ht (in)	N/A	N/A	Gutter X Slope (%)	N/A
N/A	Painted X Walk1?	No	N/A	Painted X Walk2?	N/A
	X Walk 1 Direction	To N		X Walk 2 Direction	N/A
N/A	X Walk 1 Width (in)	N/A	N/A	X Walk 2 Width (in)	N/A
	X Walk 1 Slope (%)	1.9		X Walk 2 Slope (%)	N/A
	X Walk 1 X Slope (%)	0.2		X Walk 2 X Slope (%)	N/A

N/A	Ramp inside XWalk1?	N/A	N/A	Ramp inside XWalk2?	N/A
	Road Slope (%)	N/A	N/A	Clear Space?	N/A
	Road X Slope (%)	N/A	N/A	Clear Space to XWalk (in)	N/A
N/A	Any Obstructions?	N/A	N/A	Storm Grate/Utility Hazard?	N/A
	Obstruction Type			Storm Grate/Utility Type	
		N/A			N/A
			Yes	Surface Condition? (G/P)	Good

Remove & Replace Entire Ramp.
