Access Compliance Report

Public Rights-of-Way

(Curb Ramps)

Intersection ID: 45689	Main Street: ALOYSIA_LN	Cross Street: CANIPE_FARM_CT	Location: SW
ADA ID: 923ED037CD86	Ramp Type: Perp	Initial Pass/Fail: Fail	Overall Compliance: No
		Severity Score: 10

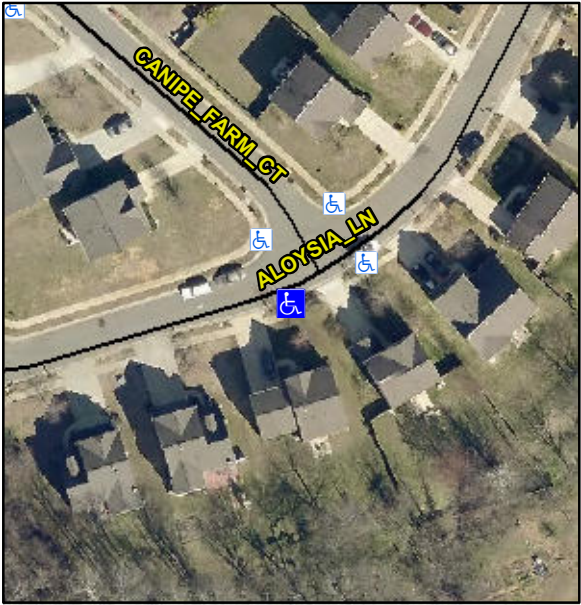
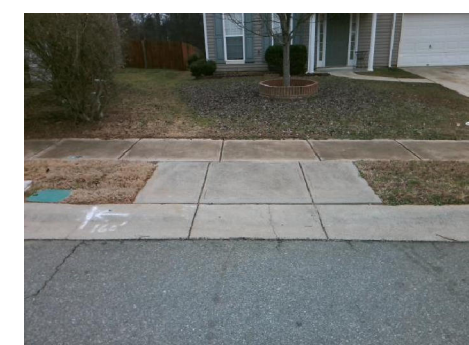
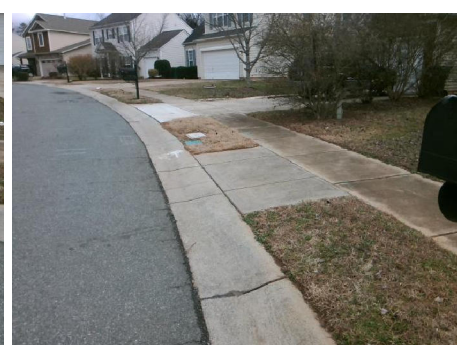
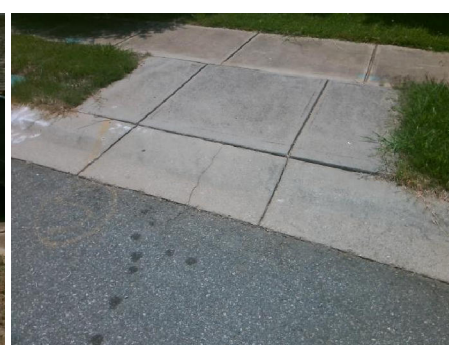
Possible Solutions:		Compliance	Description	Data	Compliance
	Remove & Replace Entire Ramp.		Description			Description
			Data			Data
			N/A	Ramp Length (in)	48.0	Yes
			No	Ramp Width (in)	46.5	Yes
			N/A	Flare Type LT	N/A	N/A
			N/A	Flare Slope LT (%)	N/A	N/A
			N/A	Flare Traversable LT?	N/A	N/A
			N/A	Landing Length (in)	N/A	N/A
			N/A	Landing Width (in)	N/A	N/A
<p>Surveyor Notes:</p> <p>N/A</p> <p>PROW/ADA:</p> <p>Not Found, R304.5.1</p>			N/A	Flare Type RT	N/A	N/A
			N/A	Flare Slope RT (%)	N/A	N/A
			N/A	Flare Traversable RT?	N/A	N/A
			N/A	DWS Provided?	N/A	N/A
			N/A	DWS Contrast?	N/A	N/A
			N/A	DWS Length (in)	N/A	N/A
			N/A	DWS Full Width?	N/A	N/A
			N/A	DWS Offset (in)	N/A	N/A
			N/A	Gutter Ponding?	N/A	N/A
			N/A	Gutter Lip Ht (in)	N/A	N/A
			N/A	Painted X Walk1?	No	N/A
				X Walk 1 Direction	To N	
			N/A	X Walk 1 Width (in)	N/A	N/A

X Walk 1 Slope (%)	2.4	
				X Walk 1 X Slope (%)	4.1	
			N/A	Ramp inside XWalk1?	N/A	N/A
				Road Slope (%)	N/A	N/A
				Road X Slope (%)	N/A	N/A
			N/A	Any Obstructions?	N/A	N/A
				Obstruction Type		
Total Cost:			\$	1850.00		
			N/A			N/A
			Yes	Surface Condition? (G/P)		Good
