# Access Compliance Report

## Public Rights-of-Way

### (Curb Ramps)

Intersection ID: 48568	Main Street: BRAMBLE RIDGE CT	Cross Street: SALAMANDER RUN LN	Location: SW
ADA ID: 9246B6DBAA83	Ramp Type: PerpDiag	Initial Pass/Fail: Pass	Overall Compliance: No
Severity Score: 0			
Codes/Mitigation Info/Possible Solution		Field Measurements/Component Compliance

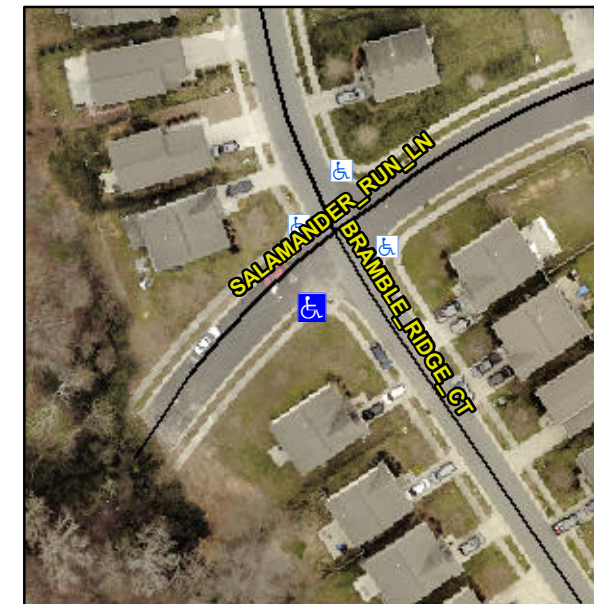
**Not Found, R304.2.1, R302.7**

Compliance	Description	Data	Compliance	Description	Data
N/A	Ramp Length (in)	47.5	Yes	Ramp Slope (%)	7.7
Yes	Ramp Width (in)	48.0	Yes	Ramp XSlope (%)	0.6
N/A	Flare Type LT	Sloped	N/A	Flare Type RT	N/A
N/A	Flare Slope LT (%)	0.9	N/A	Flare Slope RT (%)	0.8
N/A	Flare Traversable LT?	No	N/A	Flare Traversable RT?	No
No	Landing Length (in)	46.5	Yes	DWS Provided?	Yes
Yes	Landing Width (in)	80.0	Yes	DWS Contrast?	Yes
Yes	Landing Slope (%)	1.8	Yes	DWS Length (in)	24.5
Yes	Landing X Slope (%)	1.8	Yes	DWS Full Width?	Yes
N/A	Landing Curb? (Y/N)	No	Yes	DWS Offset (in)	0.0
N/A	Shared Landing?	No			
No	Gutter Ponding?	Yes	Yes	Gutter Slope (%)	4.6
Yes	Gutter Lip Ht (in)	0.0	Yes	Gutter X Slope (%)	1.9
N/A	Painted X Walk1?	No	N/A	Painted X Walk2?	No
	X Walk 1 Direction	To NE		X Walk 2 Direction	To N
N/A	X Walk 1 Width (in)	N/A	N/A	X Walk 2 Width (in)	N/A
	X Walk 1 Slope (%)	1.4		X Walk 2 Slope (%)	1.1
	X Walk 1 X Slope (%)	1.3		X Walk 2 X Slope (%)	0.2

**Remove & Replace Curb Ramp With Two New Directional Ramps or Equivalent.**

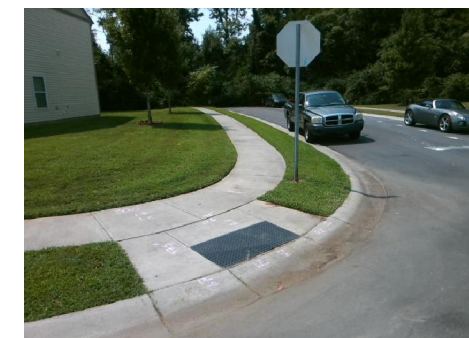
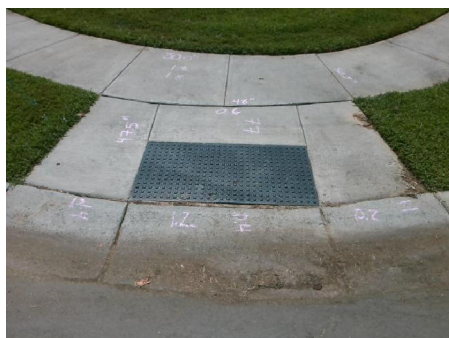
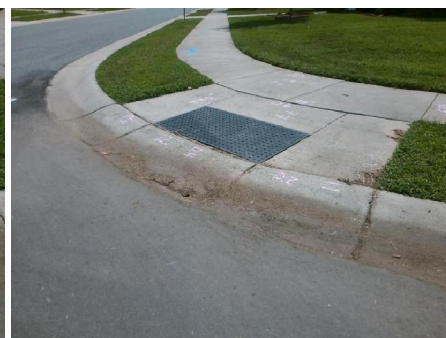
N/A	Ramp inside XWalk1?	N/A	N/A	Ramp inside XWalk2?	N/A
	Road Slope (%)	0.4	N/A	Clear Space?	Yes
	Road X Slope (%)	1.2	N/A	Clear Space to XWalk (in)	N/A
Yes	Any Obstructions?	No	Yes	Storm Grate/Utility Hazard?	No
	Obstruction Type			Storm Grate/Utility Type	
		N/A			N/A
			Yes	Surface Condition? (G/P)	Good
