Access Compliance Report Public Rights-of-Way (Curb Ramps)

Intersection ID: 48198 Main Street: RIVERGATE PY Cross Street: S_TRYON_ST Location: NE ADA ID: 9246B89ECD1D Ramp Type: Perp Initial Pass/Fail: Pass **Overall Compliance: No** Severity Score: 10.25

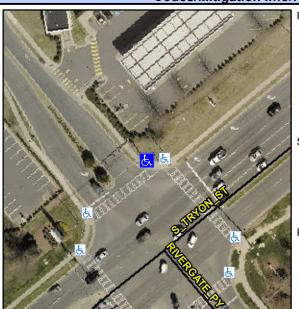
Field Measurements/Component Compliance						
Compliance Description		Data	Comp	liance	Description	Data
N/A	Ramp Length (in)	91.0	Yes	Ramp	Slope (%)	7.9
Yes	Ramp Width (in)	48.0	No	Ramp XSlope (%)		4.4
N/A	Flare Type LT	Sloped	N/A	Flare Type RT		N/A
N/A	Flare Slope LT (%)	5.9	Yes	Flare Slope RT (%)		1.6
N/A	Flare Traversable LT?	No	N/A	Flare Traversable RT?		Yes
No	Landing Length (in)	N/A	Yes	DWS	Provided?	Yes
No	Landing Width (in)	N/A	Yes	DWS	Contrast?	Yes
No	Landing Slope (%)	N/A	Yes	DWS	Length (in)	24.0
No	Landing X Slope (%)	N/A	Yes	DWS	Full Width?	Yes
N/A	Landing Curb? (Y/N)	No	No	DWS	Offset (in)	6.5
N/A	Shared Landing?	No				
Yes	Gutter Ponding?	No	Yes	Gutter	Slope (%)	3.7
Yes	Gutter Lip Ht (in)	0.0	Yes	Gutter	X Slope (%)	1.4
N/A	Painted X Walk1?	Yes	N/A	Painte	ed X Walk2?	N/A
	X Walk 1 Direction	To SW		X Wall	k 2 Direction	N/A
N/A	X Walk 1 Width (in)	102.0	N/A	X Wall	k 2 Width (in)	N/A
	X Walk 1 Slope (%)	0.3		X Wall	k 2 Slope (%)	N/A

X Walk 1 X Slope (%)	0.5		X Wall	k 2 X Slope (%)	N/A
Yes	Ramp inside XWalk1?	Yes	N/A	Ramp	inside XWalk2?	N/A
	Road Slope (%)	N/A	N/A	Clear	Space?	Yes
	Road X Slope (%)	N/A	N/A	Clear	Space to XWalk (in)	N/A
Yes	Any Obstructions?	No	Yes	Storm	Grate/Utility Hazard?	No
	Obstruction Type			Storm	Grate/Utility Type	
		N/A				N/A
			Yes	Surfac	ce Condition? (G/P)	Good
77	- me

RIVERGATE PY Street 1 Name Stop Condition-Street 2 Signal Street 2 Name N/A Stop Condition-Street 1 N/A Possible Solutions: Remove & Replace Entire Ramp. Surveyor Notes: N/A PROW/ADA: Not Found, R304.5.3, R304.2.1, R304.2.2-Perp, R304.3.2-Para, R305.2
