Access Compliance Report

Public Rights-of-Way

(Curb Ramps)

Intersection ID: 46787	Main Street: STOWE_ACRES_DR	Cross Street: MALLARD_WOODS_PL	Location: SW
ADA ID: 9247E6F60125	Ramp Type: PerpDiag	Initial Pass/Fail: Fail	Overall Compliance: No
Severity Score: 21.25			
Codes/Mitigation Info/Possible Solution		Field Measurements/Component Compliance

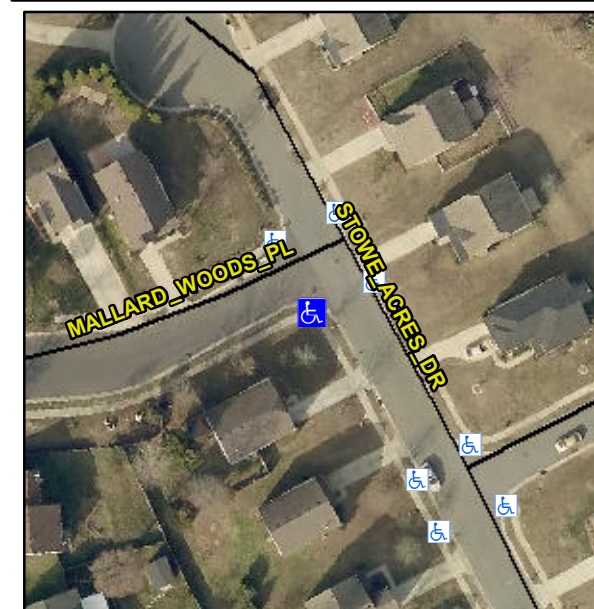
Not Found, R304.5.1, R304.5.3

Compliance	Description	Data	Compliance	Description	Data
N/A	Ramp Length (in)	49.0	Yes	Ramp Slope (%)	6.2
No	Ramp Width (in)	38.0	No	Ramp XSlope (%)	5.1
N/A	Flare Type LT	N/A	N/A	Flare Type RT	N/A
N/A	Flare Slope LT (%)	N/A	N/A	Flare Slope RT (%)	N/A
N/A	Flare Traversable LT?	N/A	N/A	Flare Traversable RT?	N/A
N/A	Landing Length (in)	N/A	N/A	DWS Provided?	N/A
N/A	Landing Width (in)	N/A	N/A	DWS Contrast?	N/A
N/A	Landing Slope (%)	N/A	N/A	DWS Length (in)	N/A
N/A	Landing X Slope (%)	N/A	N/A	DWS Full Width?	N/A
N/A	Landing Curb? (Y/N)	N/A	N/A	DWS Offset (in)	N/A
N/A	Shared Landing?	N/A			
N/A	Gutter Ponding?	N/A	N/A	Gutter Slope (%)	N/A
N/A	Gutter Lip Ht (in)	N/A	N/A	Gutter X Slope (%)	N/A
N/A	Painted X Walk1?	No	N/A	Painted X Walk2?	No
	X Walk 1 Direction	To E		X Walk 2 Direction	To N
N/A	X Walk 1 Width (in)	N/A	N/A	X Walk 2 Width (in)	N/A
	X Walk 1 Slope (%)	1.1		X Walk 2 Slope (%)	7.4
	X Walk 1 X Slope (%)	5.0		X Walk 2 X Slope (%)	1.6

N/A	Ramp inside XWalk1?	N/A	N/A	Ramp inside XWalk2?	N/A
	Road Slope (%)	0.0	N/A	Clear Space?	N/A
	Road X Slope (%)	6.4	N/A	Clear Space to XWalk (in)	N/A
N/A	Any Obstructions?	N/A	N/A	Storm Grate/Utility Hazard?	N/A
	Obstruction Type			Storm Grate/Utility Type	
		N/A			N/A
		Yes		Surface Condition? (G/P)	Good

Remove & Replace Curb Ramp With Two New Directional Ramps or Equivalent.
