Access Compliance Report

Public Rights-of-Way

(Curb Ramps)

Intersection ID: 49385	Main Street: SOUTH_DEVON_ST	Cross Street: CHARBRAY_LN	Location: E
ADA ID: 924803BA590B	Ramp Type: PerpDiag	Initial Pass/Fail: Fail	Overall Compliance: No
Severity Score: 12.5			
Codes/Mitigation Info/Possible Solution		Field Measurements/Component Compliance

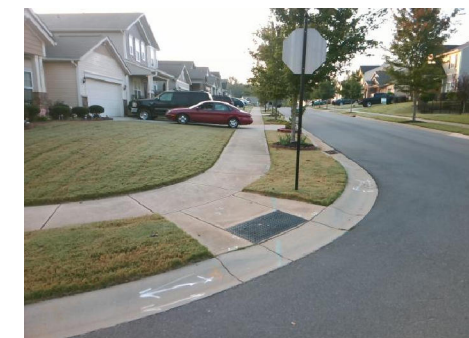
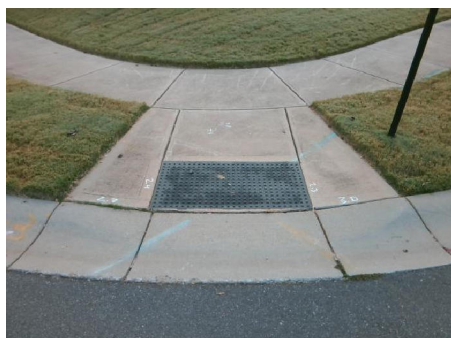
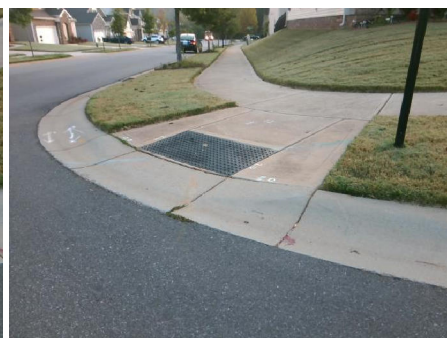
N/A	Ramp inside XWalk1?	N/A	N/A	Ramp inside XWalk2?	N/A
	Road Slope (%)	3.0	N/A	Clear Space?	N/A
	Road X Slope (%)	1.3	N/A	Clear Space to XWalk (in)	N/A
N/A	Any Obstructions?	N/A	N/A	Storm Grate/Utility Hazard?	N/A
	Obstruction Type			Storm Grate/Utility Type	
		N/A			N/A
		Yes		Surface Condition? (G/P)	Good

Remove & Replace Curb Ramp With Two New Directional Ramps or Equivalent.
