# Access Compliance Report

## Public Rights-of-Way

### (Curb Ramps)

| Intersection ID: N/A | Main Street: ROLLINGWOOD_DR | Cross Street: FIELDCREST_RD | Location: SE |

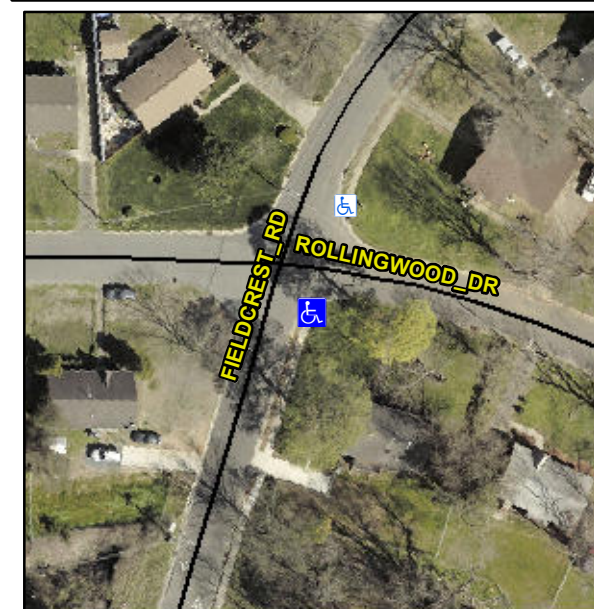
| ADA ID: 9250EF024B02 | Ramp Type: PerpDiag | Initial Pass/Fail: Fail | Overall Compliance: No |

**Not Found, R304.5.1, R304.5.3**

| Compliance | Description | Data | Compliance | Description | Data |
|---|---|---|---|---|---|
| N/A | Ramp Length (in) | 36.0 | Yes | Ramp Slope (%) | 5.8 |
| No | Ramp Width (in) | 46.5 | No | Ramp XSlope (%) | 3.1 |

**Remove & Replace Curb Ramp With Two New Directional Ramps or Equivalent.**

Total Cost: \$ 3200.00
