Access Compliance Report

Public Rights-of-Way

(Curb Ramps)

Intersection ID: 9172	Main Street: E_CRAIGHEAD_RD	Cross Street: N_TRYON_ST	Location: NE
ADA ID: 9252E7F0D369	Ramp Type: Perp	Initial Pass/Fail: Fail	Overall Compliance: No
Severity Score: 22.5			
Codes/Mitigation Info/Possible Solution		Field Measurements/Component Compliance

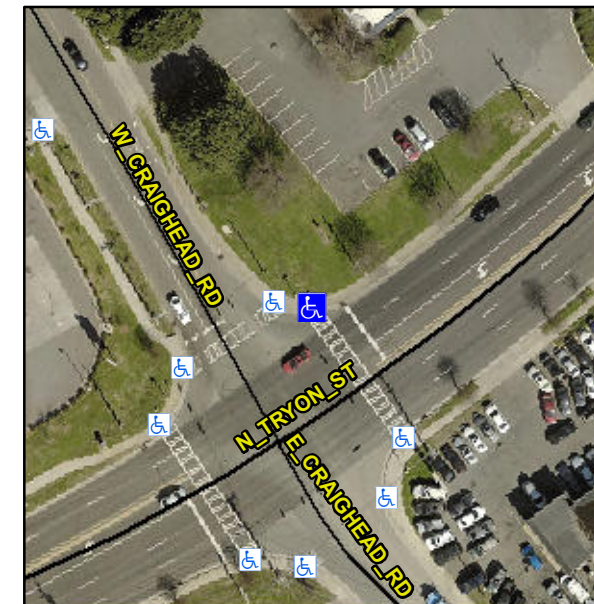
Not Found, R304.5.1, R304.2.2, R304.5.3

Compliance	Description	Data	Compliance	Description	Data
N/A	Ramp Length (in)	72.0	No	Ramp Slope (%)	8.6
No	Ramp Width (in)	43.5	No	Ramp XSlope (%)	2.5
N/A	Flare Type LT	N/A	N/A	Flare Type RT	N/A
N/A	Flare Slope LT (%)	N/A	N/A	Flare Slope RT (%)	N/A
N/A	Flare Traversable LT?	N/A	N/A	Flare Traversable RT?	N/A
N/A	Landing Length (in)	N/A	N/A	DWS Provided?	N/A
N/A	Landing Width (in)	N/A	N/A	DWS Contrast?	N/A
N/A	Landing Slope (%)	N/A	N/A	DWS Length (in)	N/A
N/A	Landing X Slope (%)	N/A	N/A	DWS Full Width?	N/A
N/A	Landing Curb? (Y/N)	N/A	N/A	DWS Offset (in)	N/A
N/A	Shared Landing?	N/A			
N/A	Gutter Ponding?	N/A	N/A	Gutter Slope (%)	N/A
N/A	Gutter Lip Ht (in)	N/A	N/A	Gutter X Slope (%)	N/A
N/A	Painted X Walk1?	Yes	N/A	Painted X Walk2?	N/A
	X Walk 1 Direction	To SE		X Walk 2 Direction	N/A
N/A	X Walk 1 Width (in)	86.0	N/A	X Walk 2 Width (in)	N/A
	X Walk 1 Slope (%)	0.1		X Walk 2 Slope (%)	N/A
	X Walk 1 X Slope (%)	1.1		X Walk 2 X Slope (%)	N/A

N/A	Ramp inside XWalk1?	Yes	N/A	Ramp inside XWalk2?	N/A
	Road Slope (%)	N/A	N/A	Clear Space?	N/A
	Road X Slope (%)	N/A	N/A	Clear Space to XWalk (in)	N/A
N/A	Any Obstructions?	N/A	N/A	Storm Grate/Utility Hazard?	N/A
	Obstruction Type			Storm Grate/Utility Type	
		N/A			N/A
			Yes	Surface Condition? (G/P)	Good

Remove & Replace Entire Ramp.
