Access Compliance Report

Public Rights-of-Way

(Curb Ramps)

Intersection ID: 10035412	Main Street: RANDOLPH_RD	Cross Street: N/A	Location: S
ADA ID: 925E021B6981	Ramp Type: PerpDiag	Initial Pass/Fail: Fail	Overall Compliance: No
		Severity Score: 35

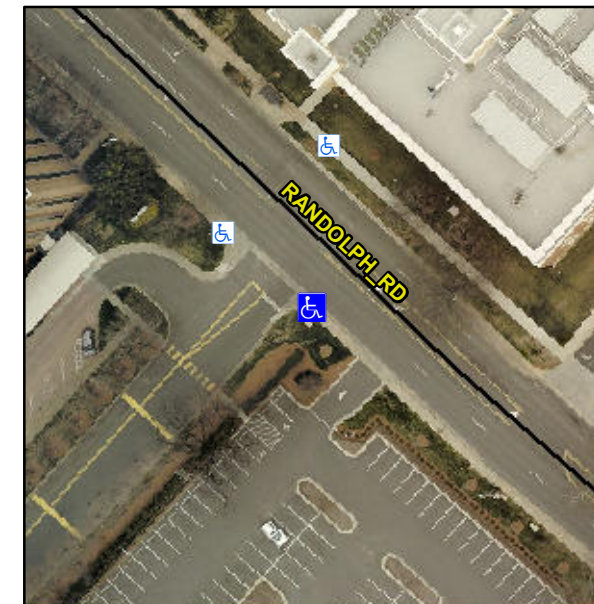
Not Found, R304.5.1, R304.2.2, R304.5.3

Compliance	Description	Data	Compliance	Description	Data
N/A	Ramp Length (in)	27.0	No	Ramp Slope (%)	14.9
No	Ramp Width (in)	41.0	No	Ramp XSlope (%)	3.0
N/A	Flare Type LT	N/A	N/A	Flare Type RT	N/A
N/A	Flare Slope LT (%)	N/A	N/A	Flare Slope RT (%)	N/A
N/A	Flare Traversable LT?	N/A	N/A	Flare Traversable RT?	N/A
N/A	Landing Length (in)	N/A	N/A	DWS Provided?	N/A
N/A	Landing Width (in)	N/A	N/A	DWS Contrast?	N/A
N/A	Landing Slope (%)	N/A	N/A	DWS Length (in)	N/A
N/A	Landing X Slope (%)	N/A	N/A	DWS Full Width?	N/A
N/A	Landing Curb? (Y/N)	N/A	N/A	DWS Offset (in)	N/A
N/A	Shared Landing?	N/A			
N/A	Gutter Ponding?	N/A	N/A	Gutter Slope (%)	N/A
N/A	Gutter Lip Ht (in)	N/A	N/A	Gutter X Slope (%)	N/A
N/A	Painted X Walk1?	No	N/A	Painted X Walk2?	No
	X Walk 1 Direction	To NE		X Walk 2 Direction	To NW
N/A	X Walk 1 Width (in)	N/A	N/A	X Walk 2 Width (in)	N/A
	X Walk 1 Slope (%)	4.0		X Walk 2 Slope (%)	2.3
	X Walk 1 X Slope (%)	4.3		X Walk 2 X Slope (%)	1.8

N/A	Ramp inside XWalk1?	N/A	N/A	Ramp inside XWalk2?	N/A
	Road Slope (%)	0.1	N/A	Clear Space?	N/A
	Road X Slope (%)	3.6	N/A	Clear Space to XWalk (in)	N/A
N/A	Any Obstructions?	N/A	N/A	Storm Grate/Utility Hazard?	N/A
	Obstruction Type			Storm Grate/Utility Type	
		N/A			N/A
			Yes	Surface Condition? (G/P)	Good

Remove & Replace Curb Ramp With Two New Directional Ramps or Equivalent.

Total Cost: \$ 3200.00
