## Access Compliance Report Public Rights-of-Way (Curb Ramps)

Intersection ID: 19935 Main Street: MORRISON_BV Cross Street: ADAIR_CT							1	014/	
Intersection ID: 19935	D: 19935 Main Street: MORRISON_BV		Cross	Street:		Location:	SW		
ADA ID: 92671688D7AA	1688D7AA Ramp Type: PerpDiag			Initial Pass/Fail: Fail Overall Compliance: No				o Severity Score:	13.75
Codes/Mitigation Info/Possible Solution				Field Measurements/Component Compliance					
		Possible Solutions:		Compliance Description Data			Compliance Description		Data
Total Contraction		Remove & Replace Curb Ramp	With	N/A	Ramp Length (in)	60.0	No	Ramp Slope (%)	10.6
and the second s		Two New Directional Ramps or		Yes	Ramp Width (in)	48.0	No	Ramp XSlope (%)	2.8
		Equivalent.		N/A	Flare Type LT	N/A	N/A	Flare Type RT	N/A
Mor				N/A	Flare Slope LT (%)	N/A	N/A	Flare Slope RT (%)	N/A
ARISO	AN A CALLER AND A			N/A	Flare Traversable LT?	N/A	N/A	Flare Traversable RT?	N/A
	and the second			N/A	Landing Length (in)	N/A	N/A	DWS Provided?	N/A

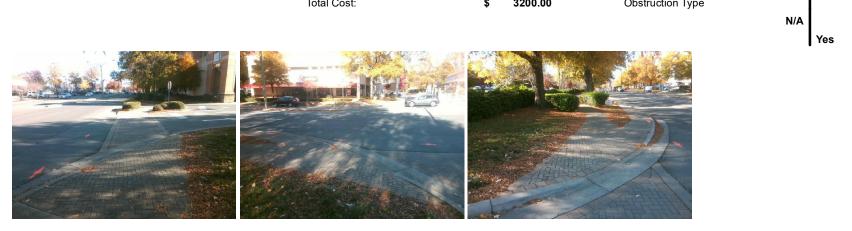
The second second		Surveyor Notes:		N/A	Landing Width (in)	N/A	N/A	DWS Contrast?	N/A
J. States		N/A		N/A	Landing Slope (%)	N/A	N/A	DWS Length (in)	N/A
				N/A	Landing X Slope (%)	N/A	N/A	DWS Full Width?	N/A
PROW/ADA:				N/A	Landing Curb? (Y/N)	N/A	N/A	DWS Offset (in)	N/A
				N/A	Shared Landing?	N/A			
				N/A	Gutter Ponding?	N/A	N/A	Gutter Slope (%)	N/A
		R304.2.2, R304.5.3		N/A	Gutter Lip Ht (in)	N/A	N/A	Gutter X Slope (%)	N/A
				N/A	Painted X Walk1?	Yes	N/A	Painted X Walk2?	No
					X Walk 1 Direction	To NE		X Walk 2 Direction	To SE
And the second of the second				N/A	X Walk 1 Width (in)	95.0	N/A	X Walk 2 Width (in)	N/A
Street 1 Name	ADAIR CT				X Walk 1 Slope (%)	3.2		X Walk 2 Slope (%)	2.2
Stop Condition-Street 2	None				X Walk 1 X Slope (%)	1.6		X Walk 2 X Slope (%)	4.4
Street 2 Name	MORRISON BV			N/A	Ramp inside XWalk1?	Yes	N/A	Ramp inside XWalk2?	N/A
Stop Condition-Street 1	StopSign				Road Slope (%)	2.9	N/A	Clear Space?	N/A

Road X Slope (%)	0.8	N/A	Clear Space to XWalk (in)	N/A
				N/A	Any Obstructions?	N/A	N/A	Storm Grate/Utility Hazard?	N/A
		Total Cost: \$	3200.00		Obstruction Type			Storm Grate/Utility Type	
						N/A			N/A
