Access Compliance Report

Public Rights-of-Way

Intersection ID: 49124	Main Street: CLARKE_CREEK_PY	Cross Street: LEGOLAS_LN	Location: SW
ADA ID: 92765046C45C	Ramp Type: PerpDiag	Initial Pass/Fail: Fail	Overall Compliance: No
		Severity Score: 10

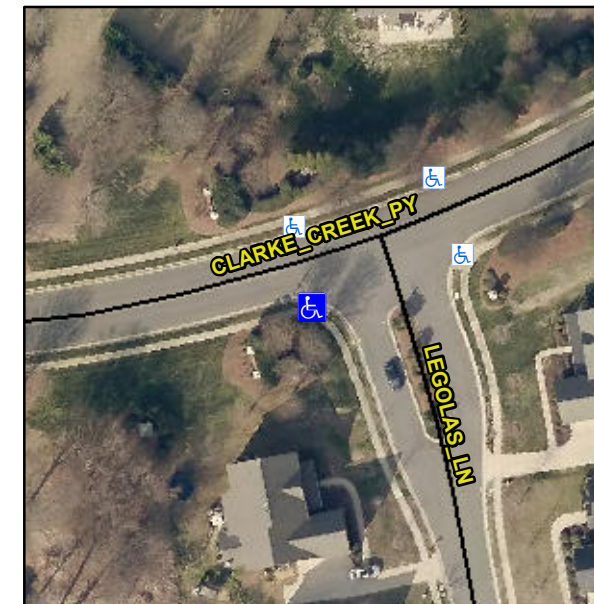
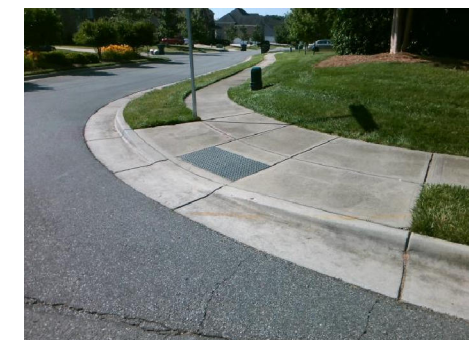
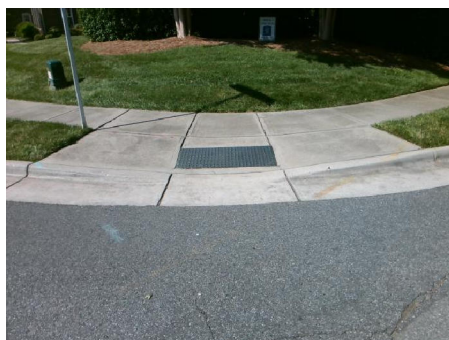
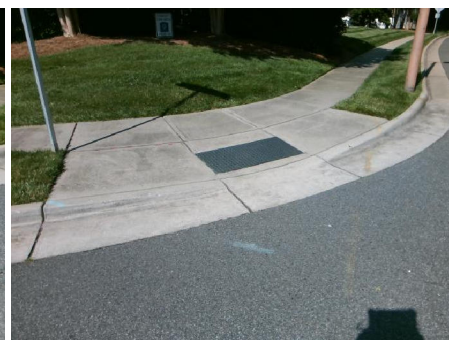
Compliance	Description	Data	Compliance	Description	Data
N/A	Ramp Length (in)	44.0	Yes	Ramp Slope (%)	6.2
No	Ramp Width (in)	46.0	No	Ramp XSlope (%)	2.5
N/A	Flare Type LT	N/A	N/A	Flare Type RT	N/A
N/A	Flare Slope LT (%)	N/A	N/A	Flare Slope RT (%)	N/A
N/A	Flare Traversable LT?	N/A	N/A	Flare Traversable RT?	N/A
N/A	Landing Length (in)	N/A	N/A	DWS Provided?	N/A
N/A	Landing Width (in)	N/A	N/A	DWS Contrast?	N/A
N/A	Landing Slope (%)	N/A	N/A	DWS Length (in)	N/A
N/A	Landing X Slope (%)	N/A	N/A	DWS Full Width?	N/A
N/A	Landing Curb? (Y/N)	N/A	N/A	DWS Offset (in)	N/A
N/A	Shared Landing?	N/A			
N/A	Gutter Ponding?	N/A	N/A	Gutter Slope (%)	N/A
N/A	Gutter Lip Ht (in)	N/A	N/A	Gutter X Slope (%)	N/A
N/A	Painted X Walk1?	No	N/A	Painted X Walk2?	No
	X Walk 1 Direction	To E		X Walk 2 Direction	To N
N/A	X Walk 1 Width (in)	N/A	N/A	X Walk 2 Width (in)	N/A
	X Walk 1 Slope (%)	0.3		X Walk 2 Slope (%)	0.5
	X Walk 1 X Slope (%)	2.5		X Walk 2 X Slope (%)	1.1

N/A	Ramp inside XWalk1?	N/A	N/A	Ramp inside XWalk2?	N/A
	Road Slope (%)	2.4	N/A	Clear Space?	N/A
	Road X Slope (%)	1.4	N/A	Clear Space to XWalk (in)	N/A
N/A	Any Obstructions?	N/A	N/A	Storm Grate/Utility Hazard?	N/A
	Obstruction Type			Storm Grate/Utility Type	
		N/A			N/A
			Yes	Surface Condition? (G/P)	Good

Remove & Replace Curb Ramp With Two New Directional Ramps or Equivalent.

R304.5.1, R304.5.3
