# Access Compliance Report

## Public Rights-of-Way

### (Curb Ramps)

Intersection ID: 26041	Main Street: PROVIDENCE COLONY DR	Cross Street: RAINTREE LN	Location: SE
ADA ID: 927A7CE01C8E	Ramp Type: Perp	Initial Pass/Fail: Fail	Overall Compliance: No
Severity Score: 35			
Codes/Mitigation Info/Possible Solution		Field Measurements/Component Compliance

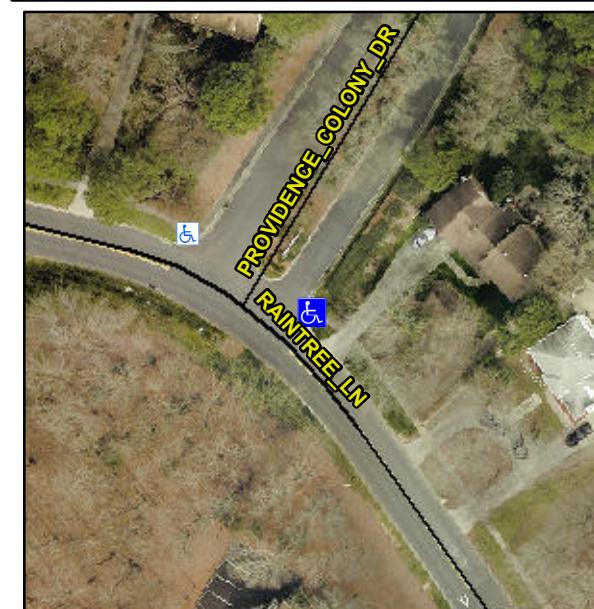
**Not Found, R304.5.1, R304.2.2, R304.5.3**

Compliance	Description	Data	Compliance	Description	Data
N/A	Ramp Length (in)	91.0	No	Ramp Slope (%)	20.0
No	Ramp Width (in)	46.0	No	Ramp XSlope (%)	2.5
N/A	Flare Type LT	N/A	N/A	Flare Type RT	N/A
N/A	Flare Slope LT (%)	N/A	N/A	Flare Slope RT (%)	N/A
N/A	Flare Traversable LT?	N/A	N/A	Flare Traversable RT?	N/A
N/A	Landing Length (in)	N/A	N/A	DWS Provided?	N/A
N/A	Landing Width (in)	N/A	N/A	DWS Contrast?	N/A
N/A	Landing Slope (%)	N/A	N/A	DWS Length (in)	N/A
N/A	Landing X Slope (%)	N/A	N/A	DWS Full Width?	N/A
N/A	Landing Curb? (Y/N)	N/A	N/A	DWS Offset (in)	N/A
N/A	Shared Landing?	N/A			
N/A	Gutter Ponding?	N/A	N/A	Gutter Slope (%)	N/A
N/A	Gutter Lip Ht (in)	N/A	N/A	Gutter X Slope (%)	N/A
N/A	Painted X Walk1?	No	N/A	Painted X Walk2?	N/A
	X Walk 1 Direction	To N		X Walk 2 Direction	N/A
N/A	X Walk 1 Width (in)	N/A	N/A	X Walk 2 Width (in)	N/A
	X Walk 1 Slope (%)	3.9		X Walk 2 Slope (%)	N/A
	X Walk 1 X Slope (%)	4.5		X Walk 2 X Slope (%)	N/A

N/A	Ramp inside XWalk1?	N/A	N/A	Ramp inside XWalk2?	N/A
	Road Slope (%)	N/A	N/A	Clear Space?	N/A
	Road X Slope (%)	N/A	N/A	Clear Space to XWalk (in)	N/A
N/A	Any Obstructions?	N/A	N/A	Storm Grate/Utility Hazard?	N/A
	Obstruction Type			Storm Grate/Utility Type	
		N/A			N/A
			Yes	Surface Condition? (G/P)	Good

Possible Solutions:

**Remove & Replace Entire Ramp.**
