# Access Compliance Report

## Public Rights-of-Way (Curb Ramps)

| Intersection ID: N/A | Main Street: KIMMERLY_GLEN_LN | Cross Street: KIMMERLY_CREEK_DR | Location: NW |
| ADA ID: 92903CF07AC1 | Ramp Type: Directional | Initial Pass/Fail: Pass | Overall Compliance: No<br>Severity Score: 10.25 |

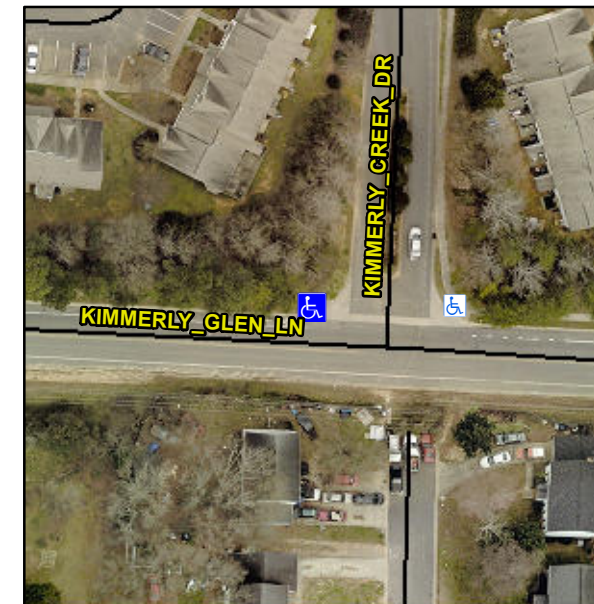
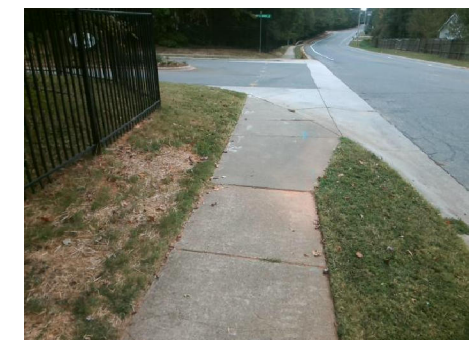
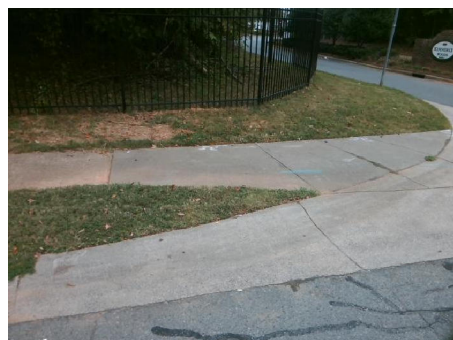
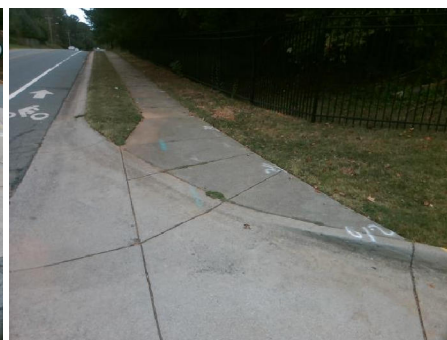
**R304.5.3, R304.2.2-Perp, R304.3.2-Para, R305**

| Compliance | Description | Data | Compliance | Description | Data |
|---|---|---|---|---|---|
| Yes | Ramp Slope (%) | 1.7 | No | Grade Break XSlope (%) | 4.0 |
| No | Ramp XSlope (%) | 2.3 | | | |
| Yes | Landing Length (in) | 51.5 | No | DWS Provided? | No |
| No | Landing Slope (%) | 2.1 | N/A | DWS Length (in) | N/A |
| No | Landing X Slope (%) | 3.9 | N/A | DWS Full Width? | No |

**Remove & Replace Entire Ramp.**

Total Cost: \$ 1600.00
