Access Compliance Report

Public Rights-of-Way

| Intersection ID: 11148 | Main Street: MATHESON_AV | Cross Street: VIRGINIA_AV | Location: | N |
| ADA ID: 929179D0C502 | Ramp Type: PerpDiag | Initial Pass/Fail: Fail | Overall Compliance: No | Severity Score: 33.75 |

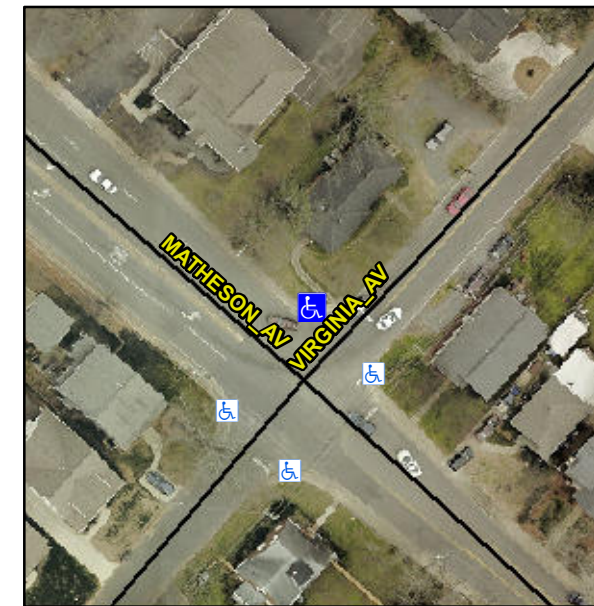
Not Found, R304.5.1, R304.5.3

| Compliance | Description | Data | Compliance | Description | Data |
|---|---|---|---|---|---|
| N/A | Ramp Length (in) | 49.0 | Yes | Ramp Slope (%) | 5.8 |
| No | Ramp Width (in) | 39.5 | No | Ramp XSlope (%) | 10.0 |

Remove & Replace Curb Ramp With Two New Directional Ramps or Equivalent.

Total Cost: \$ 3200.00
