Access Compliance Report

Public Rights-of-Way

(Curb Ramps)

Intersection ID: 9685	Main Street: EDGEWOOD_RD	Cross Street: SUSAN_ST	Location:	N
ADA ID: 9299D6CF8867	Ramp Type: Perp	Initial Pass/Fail: Fail	Overall Compliance: No	Severity Score: 8.75

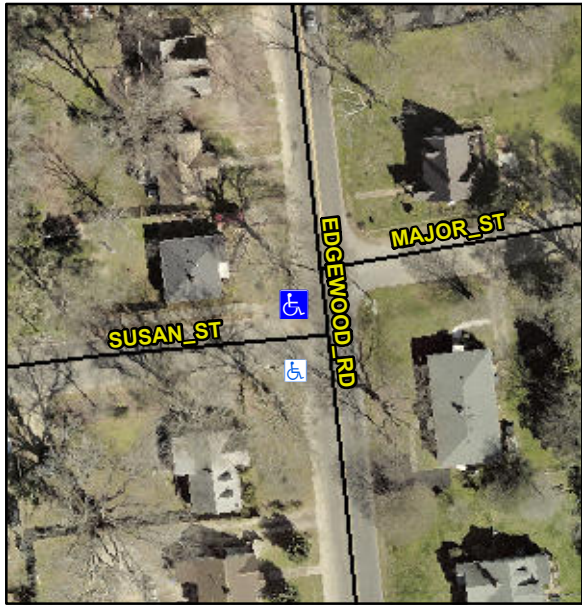
Possible Solutions:		Compliance			Description			Data	Compliance			Description			Data
	Remove & Replace Entire Ramp.		N/A	Ramp Length (in)			56.0			Yes	Ramp Slope (%)			5.3		
			No	Ramp Width (in)			38.0			Yes	Ramp XSlope (%)			0.3		
			N/A	Flare Type LT			N/A			N/A	Flare Type RT			N/A		
			N/A	Flare Slope LT (%)			N/A			N/A	Flare Slope RT (%)			N/A		
			N/A	Flare Traversable LT?			N/A			N/A	Flare Traversable RT?			N/A		
			N/A	Landing Length (in)			N/A			N/A	DWS Provided?			N/A		
			N/A	Landing Width (in)			N/A			N/A	DWS Contrast?			N/A		
			N/A	Landing Slope (%)			N/A			N/A	DWS Length (in)			N/A		
			N/A	Landing X Slope (%)			N/A			N/A	DWS Full Width?			N/A		
Surveyor Notes:		N/A	N/A			N/A			N/A	DWS Offset (in)			N/A			
PROW/ADA:		R304.5.1	N/A			N/A			N/A	Gutter Ponding?			N/A			
			N/A			N/A			N/A	Gutter Lip Ht (in)			0.5

N/A			N/A			No	Painted X Walk2?			N/A			
						X Walk 1 Direction			To S	X Walk 2 Direction			N/A			
			N/A			X Walk 1 Width (in)			N/A	X Walk 2 Width (in)			N/A			
						X Walk 1 Slope (%)			0.3	X Walk 2 Slope (%)			N/A			
						X Walk 1 X Slope (%)			1.4	X Walk 2 X Slope (%)			N/A			
Street 1 Name		SUSAN ST	N/A			N/A			N/A	Ramp inside XWalk2?			N/A			
Stop Condition-Street 2		StopSign	N/A			N/A			N/A	Clear Space?			N/A			
Street 2 Name		N/A	N/A			N/A			N/A	Clear Space to XWalk (in)			N/A			
Stop Condition-Street 1		N/A	N/A			N/A			N/A	Storm Grate/Utility Hazard?			N/A			
Total Cost:		\$ 1850.00	Obstruction Type						N/A	Storm Grate/Utility Type			N/A			
									N/A	Yes			Surface Condition? (G/P) Good
