# Access Compliance Report

## Public Rights-of-Way

### (Curb Ramps)

| Intersection ID: N/A | Main Street: NORTHLAKE CENTRE PY | Cross Street: N/A | Location: SE |

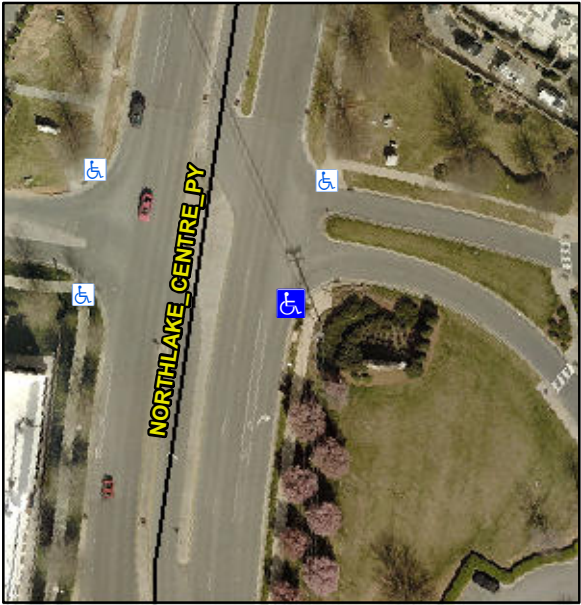
| ADA ID: 92B166388904 | Ramp Type: PerpDiag | Initial Pass/Fail: Fail | Overall Compliance: No |
| Severity Score: 8.75 | | | |

| | | | No | Ramp Width (in) | 45.5 | Yes | Ramp XSlope (%) | 1.6 |
| <p>Surveyor Notes:</p> <p>N/A</p> <p>PROW/ADA:</p> <p>R304.5.1</p> | | | | Road Slope (%) | 0.1 | N/A | Clear Space? | N/A |

| | Remove & Replace Curb Ramp With Two New Directional Ramps or Equivalent. | | N/A | Ramp Length (in) | 51.0 | Yes | Ramp Slope (%) | 5.2 |
