Access Compliance Report

Public Rights-of-Way

(Curb Ramps)

Intersection ID: 15217	Main Street: ALBEMARLE_RD	Cross Street: WINTERHAVEN_DR	Location: NE
ADA ID: 92B6B138E1B5	Ramp Type: PerpDiag	Initial Pass/Fail: Fail	Overall Compliance: No
Codes/Mitigation Info/Possible Solution		Field Measurements/Component Compliance

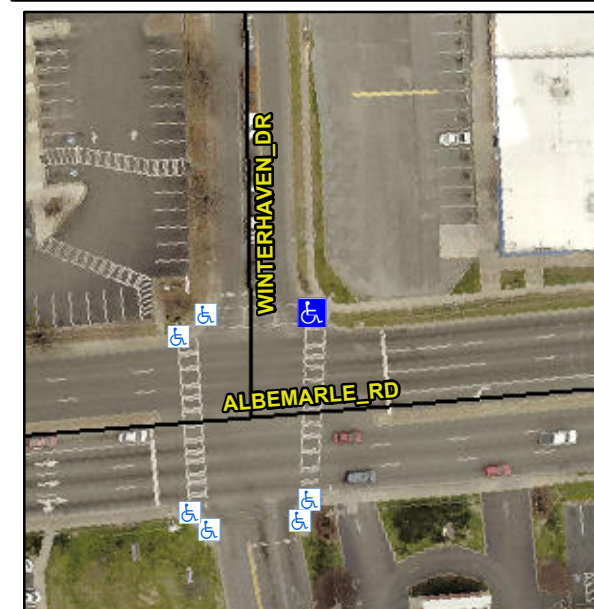
Not Found, R304.2.2

Compliance	Description	Data	Compliance	Description	Data
N/A	Ramp Length (in)	60.0	No	Ramp Slope (%)	8.6
Yes	Ramp Width (in)	52.0	Yes	Ramp XSlope (%)	2.2
N/A	Flare Type LT	N/A	N/A	Flare Type RT	N/A
N/A	Flare Slope LT (%)	N/A	N/A	Flare Slope RT (%)	N/A
N/A	Flare Traversable LT?	N/A	N/A	Flare Traversable RT?	N/A
N/A	Landing Length (in)	N/A	N/A	DWS Provided?	N/A
N/A	Landing Width (in)	N/A	N/A	DWS Contrast?	N/A
N/A	Landing Slope (%)	N/A	N/A	DWS Length (in)	N/A
N/A	Landing X Slope (%)	N/A	N/A	DWS Full Width?	N/A
N/A	Landing Curb? (Y/N)	N/A	N/A	DWS Offset (in)	N/A
N/A	Shared Landing?	N/A			
N/A	Gutter Ponding?	N/A	N/A	Gutter Slope (%)	N/A
N/A	Gutter Lip Ht (in)	N/A	N/A	Gutter X Slope (%)	N/A
N/A	Painted X Walk1?	Yes	N/A	Painted X Walk2?	Yes
	X Walk 1 Direction	To E		X Walk 2 Direction	To S
N/A	X Walk 1 Width (in)	112.0	N/A	X Walk 2 Width (in)	108.0
	X Walk 1 Slope (%)	3.3		X Walk 2 Slope (%)	1.4
	X Walk 1 X Slope (%)	4.2		X Walk 2 X Slope (%)	0.8

N/A	Ramp inside XWalk1?	Yes	N/A	Ramp inside XWalk2?	Yes
	Road Slope (%)	3.5	N/A	Clear Space?	N/A
	Road X Slope (%)	2.8	N/A	Clear Space to XWalk (in)	N/A
N/A	Any Obstructions?	N/A	N/A	Storm Grate/Utility Hazard?	N/A
	Obstruction Type			Storm Grate/Utility Type	
		N/A			N/A
		Yes		Surface Condition? (G/P)	Good

Possible Solutions:

Remove & Replace Curb Ramp With Two New Directional Ramps or Equivalent.
