Access Compliance Report

Public Rights-of-Way

(Curb Ramps)

Intersection ID: N/A	Main Street: SCONE_PALACE_CT	Cross Street: N/A	Location: SW
ADA ID: 92C4A79ADDF9	Ramp Type: Perp	Initial Pass/Fail: Fail	Overall Compliance: No
Codes/Mitigation Info/Possible Solution		Field Measurements/Component Compliance

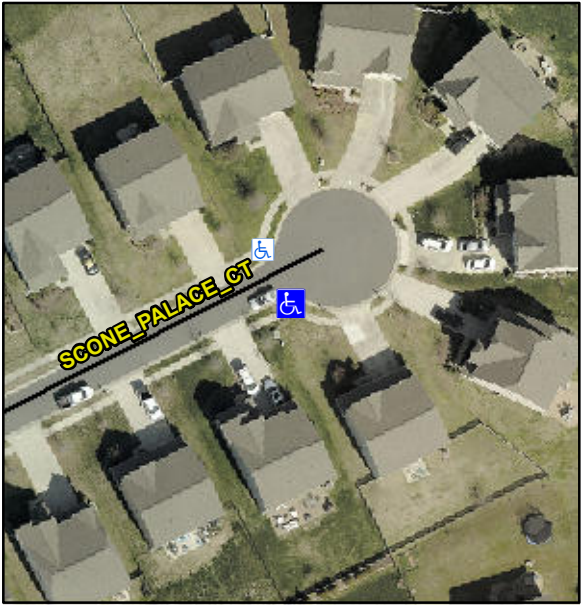
Possible Solutions:						
	Remove & Replace Entire Ramp.						
	Surveyor Notes:						
	N/A						
	PROW/ADA:						
	R304.5.3						
	Street 1 Name	SCONE PALACE CT					
	Stop Condition-Street 2	None					
	Street 2 Name	N/A					
	Stop Condition-Street 1	N/A					
	Total Cost:	\$ 1850.00					
			Compliance	Description	Data	Compliance	Description
			N/A	Ramp Length (in)	47.0	Yes	Ramp Slope (%)
			Yes	Ramp Width (in)	48.0	No	Ramp XSlope (%)
			N/A	Flare Type LT	N/A	N/A	Flare Type RT
			N/A	Flare Slope LT (%)	N/A	N/A	Flare Slope RT (%)
			N/A	Flare Traversable LT?	N/A	N/A	Flare Traversable RT?
			N/A	Landing Length (in)	N/A	N/A	DWS Provided?
			N/A	Landing Width (in)	N/A	N/A	DWS Contrast?
			N/A	Landing Slope (%)	N/A	N/A	DWS Length (in)
			N/A	Landing X Slope (%)	N/A	N/A	DWS Full Width?
			N/A	Landing Curb? (Y/N)	N/A	N/A	DWS Offset (in)
			N/A	Shared Landing?	N/A		
			N/A	Gutter Ponding?	N/A	N/A	Gutter Slope (%)
			N/A	Gutter Lip Ht (in)	N/A	N/A	Gutter X Slope (%)

N/A	Painted X Walk1?	No	N/A	Painted X Walk2?
				X Walk 1 Direction	To NW		X Walk 2 Direction
			N/A	X Walk 1 Width (in)	N/A	N/A	X Walk 2 Width (in)
				X Walk 1 Slope (%)	4.5		X Walk 2 Slope (%)
				X Walk 1 X Slope (%)	3.9		X Walk 2 X Slope (%)
			N/A	Ramp inside XWalk1?	N/A	N/A	Ramp inside XWalk2?
				Road Slope (%)	N/A	N/A	Clear Space?
				Road X Slope (%)	N/A	N/A	Clear Space to XWalk (in)
			N/A	Any Obstructions?	N/A	N/A	Storm Grate/Utility Hazard?
				Obstruction Type			Storm Grate/Utility Type
					N/A		N/A
					Yes		Surface Condition? (G/P)
							Good
